TOWN OF PINCHER CREEK COUNCIL MEETING AGENDA

In the 2021 Lebel Mansion Facility Lifecycle Assessment it was noted (A02.6)

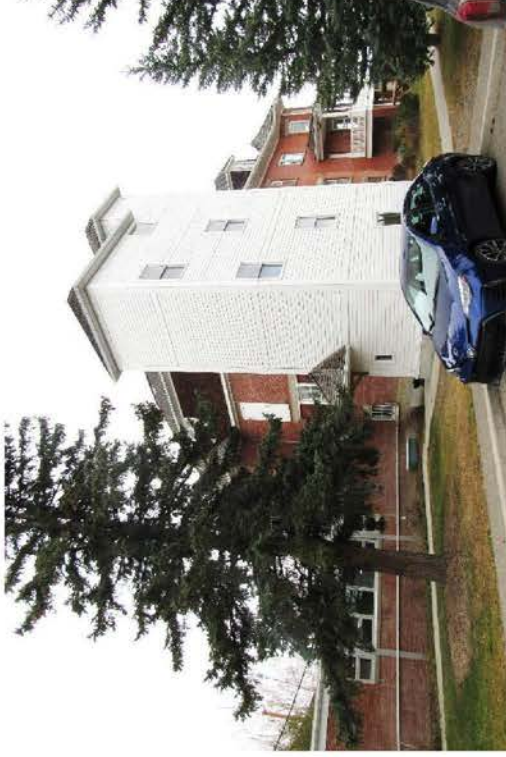
'the majority of the windows and the stair/elevator tower are showing signs of deteriorated paint.' This portion was originally painted in 2006.

Photo #A6: General view of exterior claddings showing the stair/elevator tower. (Brick masonry, Cedar shakes, Wood panels and Wood sidings).

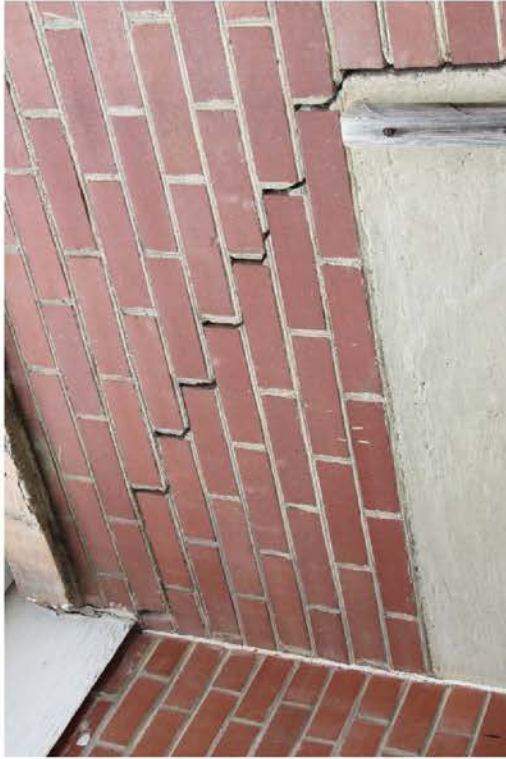
Step cracking of the brick veneer mostly at the top of the windows was observed in the east and west elevation of the main building. Load bearing block wall vertical cracks at the Pottery Studio were observed. We recommend these cracks be filled and sealed to prevent further deterioration.

Photo #A7: Step cracking on the brick masonry.

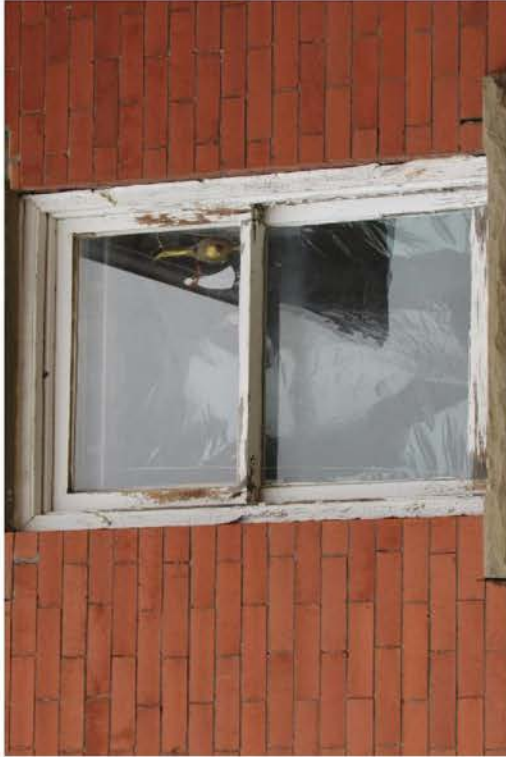
Photo #A9: Current condition of wood windows.

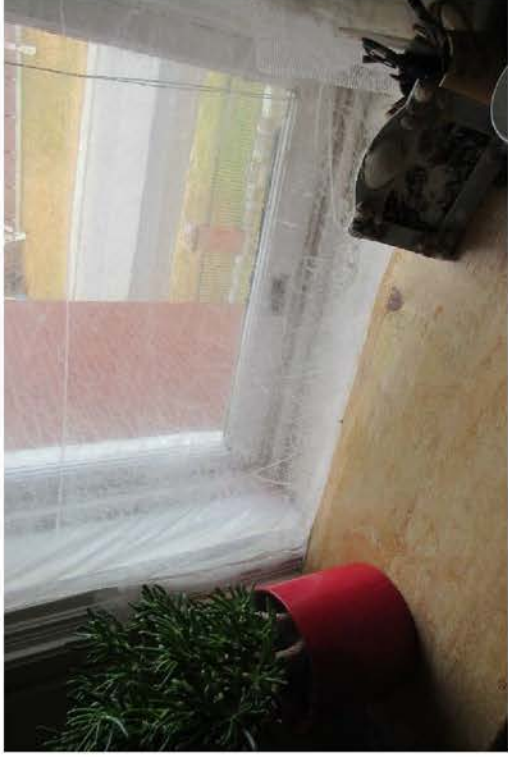
Photo #A20: Window in the room #206 (air infiltration observed).

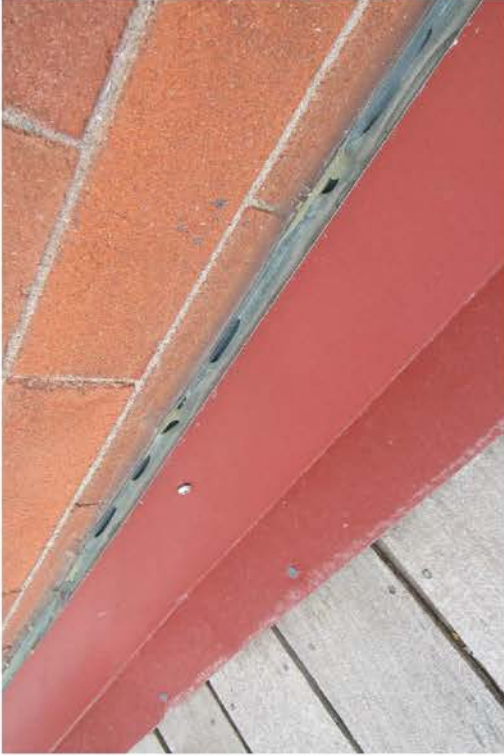
Photo #A23: Joint sealant failure.

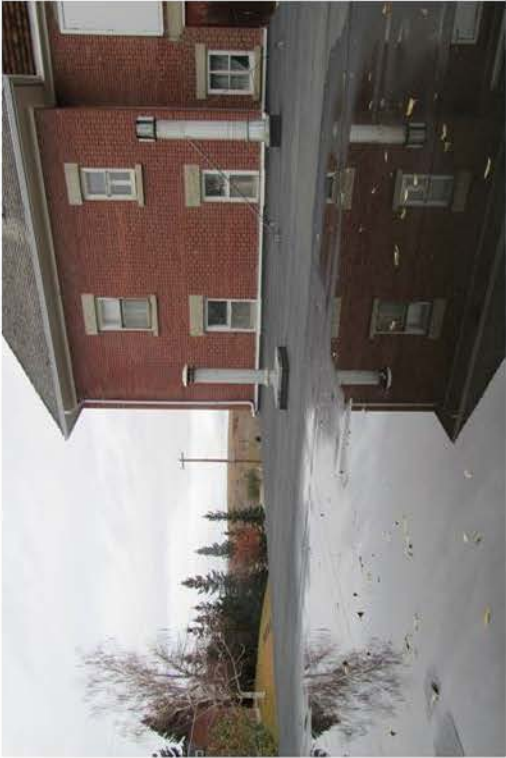
Photo #A25: SBS flat roof (Water pond observed).

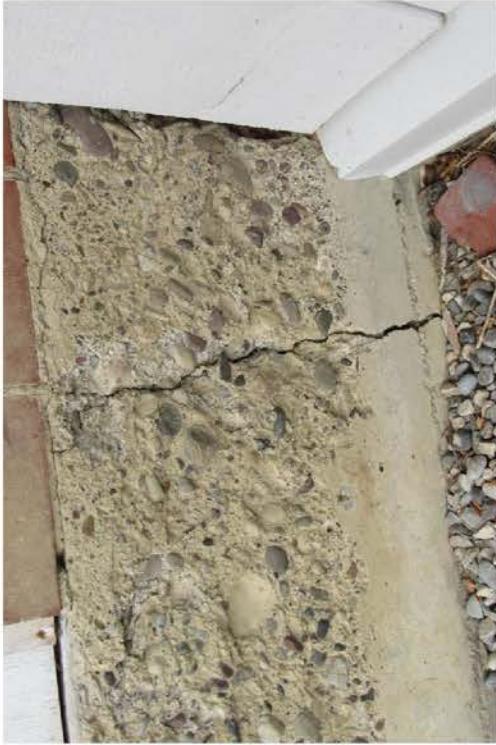
Photo #S1: Crack on foundation wall.

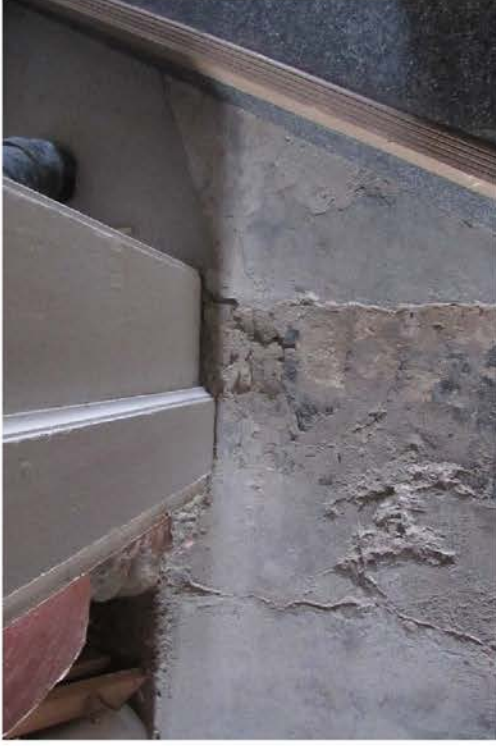
Shrinkage cracks, crazing, concrete spalling, and abraded floor surface were observed in the concrete slab on grade at the main building and we recommend these cracks be filled and sealed to prevent further deterioration and monitored for additional movement. The floor slab at the Pottery Studio is covered with ceramic tiles and structural components could not be viewed. We assumed the floor slab to be consisted of cast-in place concrete slab on grade. No cracks and ground settlement of the floor was observed.

Photo #S2: Cracks and spalling on the SOG.

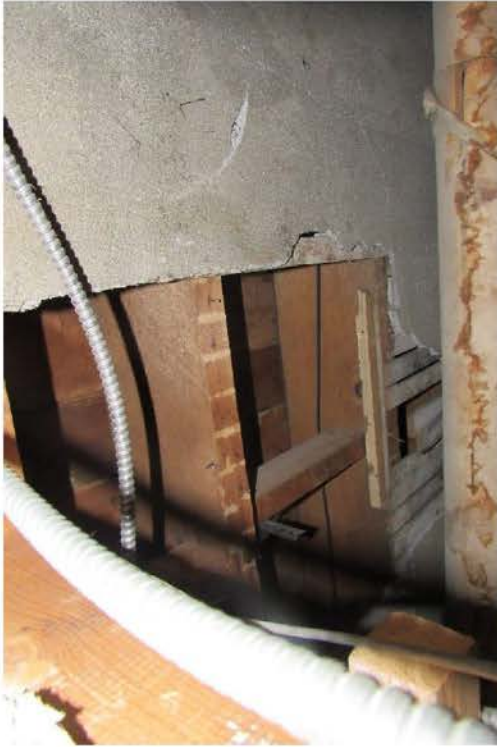
The wood elements in the building are generally in marginal condition. The wood framing for the roof and walls has reached the end of its expected useful life. We recommend a structural study be completed to review the condition of the wood framing in the building.

Photo #S3: Wood framing (joist & studs).

- RAI.4) Wood framing (roof & interior walls) study.
- No other recommended additional investigation required.

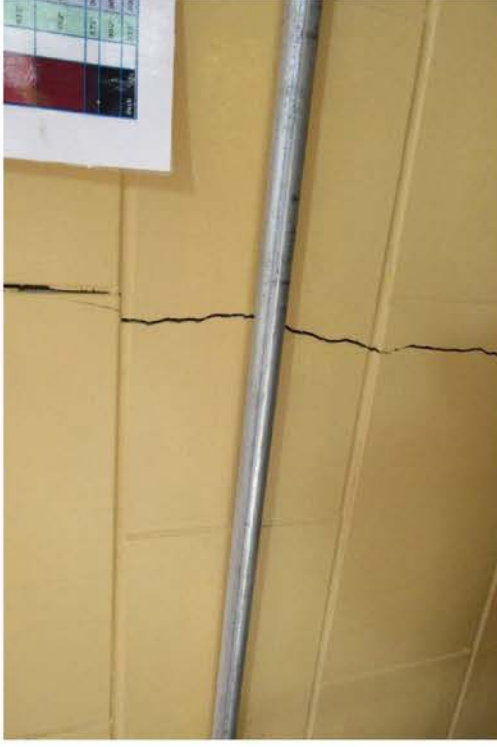
Photo #S4: Vertical cracks in CMU wall in the pottery studio.

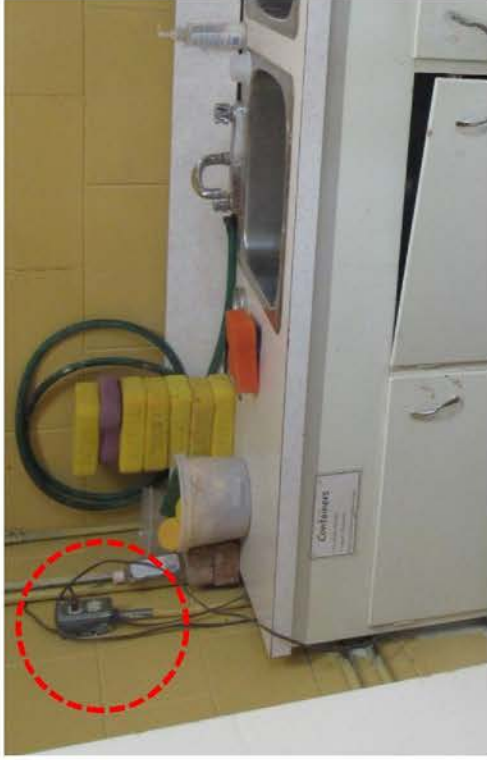
The electrical components are in overall acceptable condition. Immediate action items with respect to GFCI receptacles is required. Capital expenditures with respect to the electrical subpanels, interior/exterior lighting and controls, emergency light battery packs, exit signs, exterior lighting, fire alarm panel, security camera and intrusion detector are anticipated within the evaluation period. No additional investigation is recommended at this time.

Photo #E5: GFCI receptacle are not installed in pottery studio.

Immediate investigation / action items identified pertain to Installation of GFCI receptacles and cover plates where necessary. Deficiencies and Capital Reserve Items have been identified within the 20-Year time frame of this report with respect to architectural, structural, mechanical and electrical components and systems. The Immediate Repairs and Capital Reserve Analysis are included in Appendix C.
