# TOWN OF PINCHER CREEK COUNCIL MEETING AGENDA

Monday, May 9, 2022 at 6:00 p.m.

# FINAL REPORT

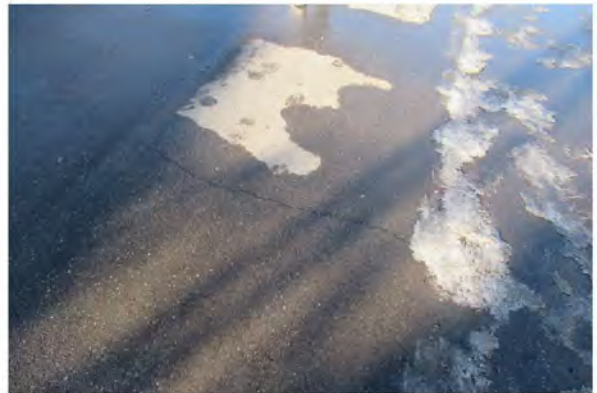
Photo #A2: Asphalt Cracks in parking lot.

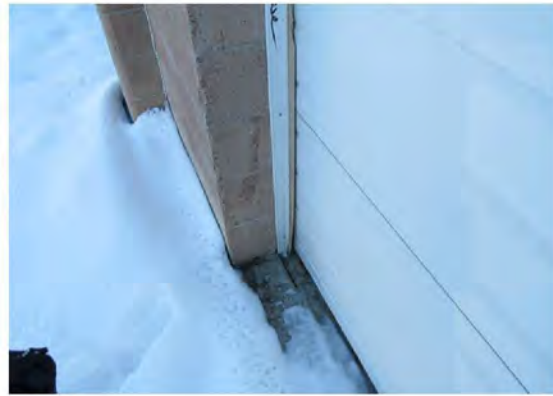
**Photo #A8:** Improper sealant (weather stripping) shown at the overhead door on the rear of the building.

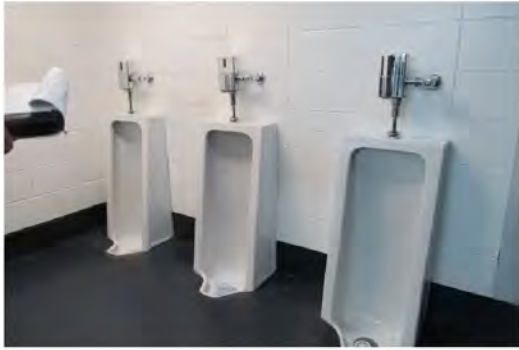
**Photo #A17:** Urinals located in main lobby washroom; not barrier free compliant.

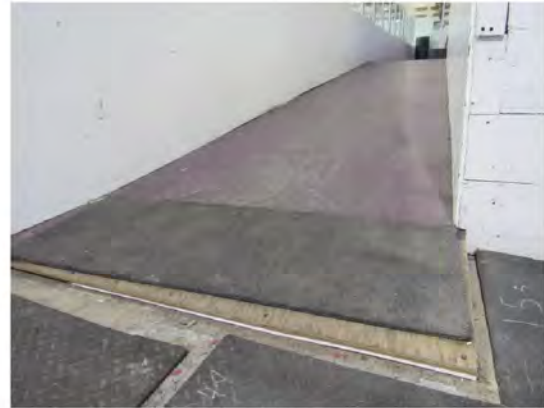
**Photo #A18:** Tripping hazard and lack of handrails on barrier free ramp near bleachers.

Immediate investigation / action items identified pertain to repair of tripping hazard on wheelchair ramp, installation of GFCI receptacles where necessary and replace damaged junction boxes. Deficiencies and Capital Reserve Items have been identified within the 20-Year time frame of this report with respect to architectural, mechanical and electrical components and systems. The Immediate Repairs and Capital Reserve Analysis are included in Appendix C.

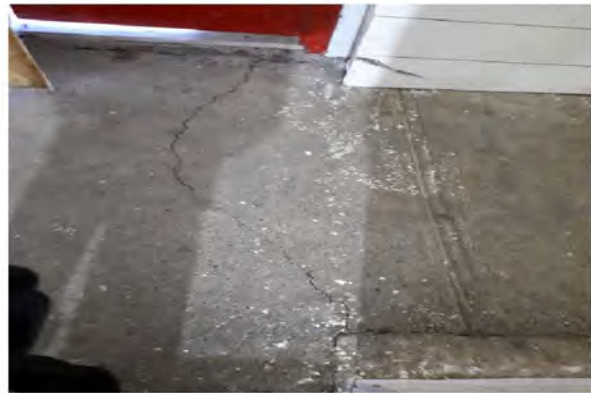
**Photo #S2:** Crack in slab-on-grade under the seating area.

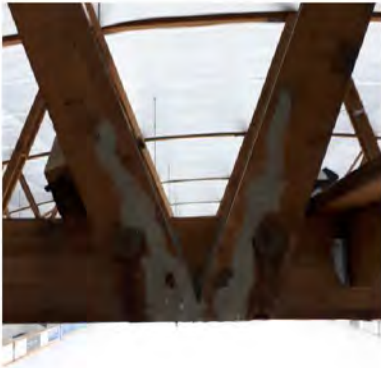
**Photo #S5:** Repaired cracks in wood members of trusses.

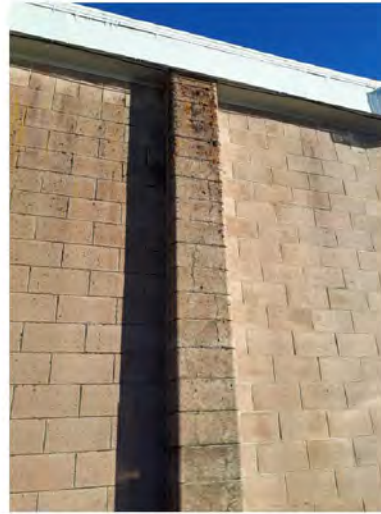
**Photo #S6:** Cracks in pier of the exterior CMU wall.

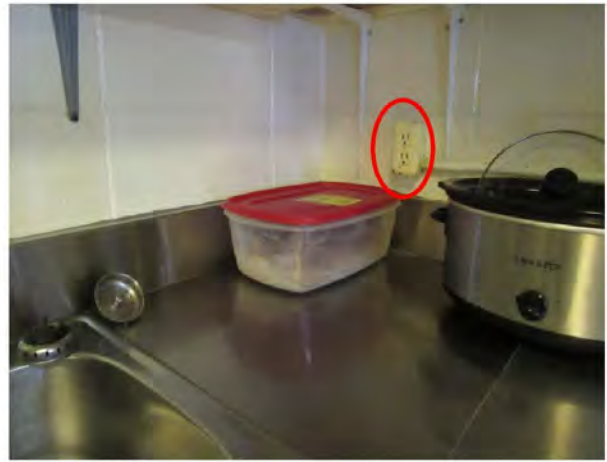
**Photo #E6:** Non GFCI receptacle found within 1 meter of a sink.
