# TOWN OF PINCHER CREEK COUNCIL MEETING AGENDA

<b>SUBJECT:</b> Operations Facility - Condition Assessment & Needs Assessment	
<b>PRESENTED BY:</b> Laurie Wilgosh, Chief Administrative Officer	<b>DATE OF MEETING:</b> 10/24/2022

## Program Plan and Conceptual Design for the Operations Facility 1068 Kettles St, Pincher Creek, AB

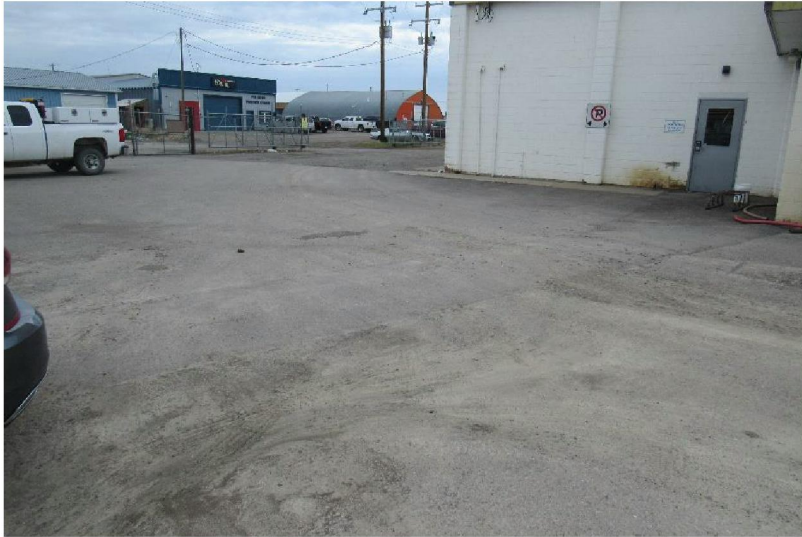
**Photo #A1:** Asphalt paved parking lot located in the west side of the Main Shop.

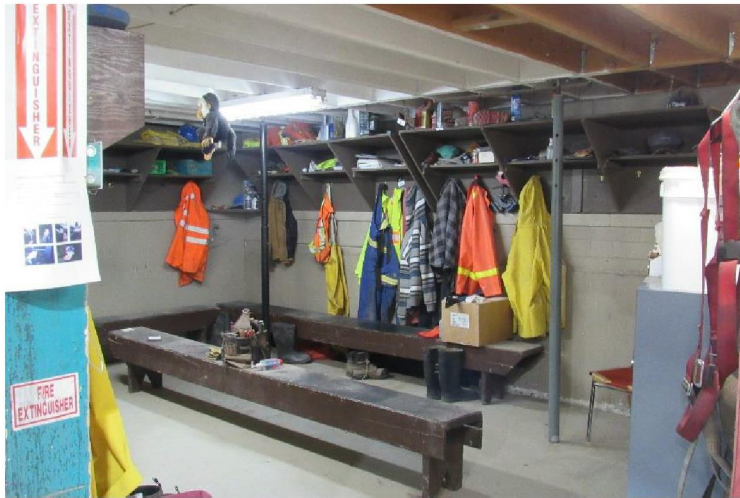
Only one change area is provided, which is inadequate for a co-ed staff.

Photo #A9: General view of changing room in the Main Shop.

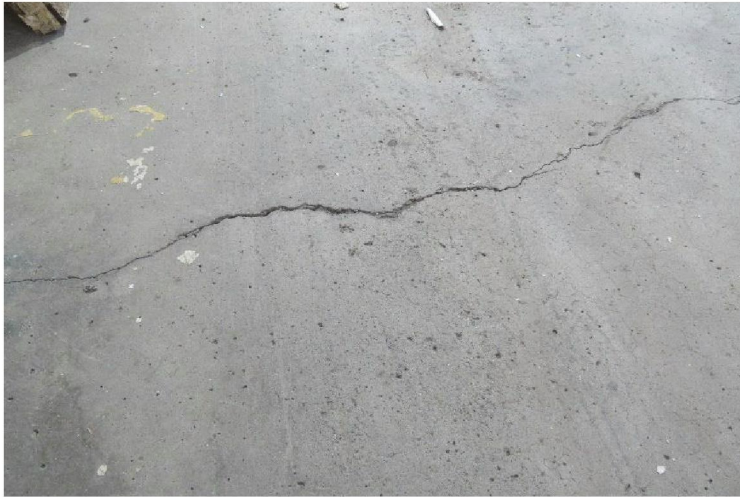
The structural components are in overall acceptable condition. Capital expenditures with respect to slab-on-grad are anticipated within the evaluation period. No immediate action items have been identified. No additional investigation is recommended at this time.

**Photo #S1:** Cracks on the SOG in the Main Shop.

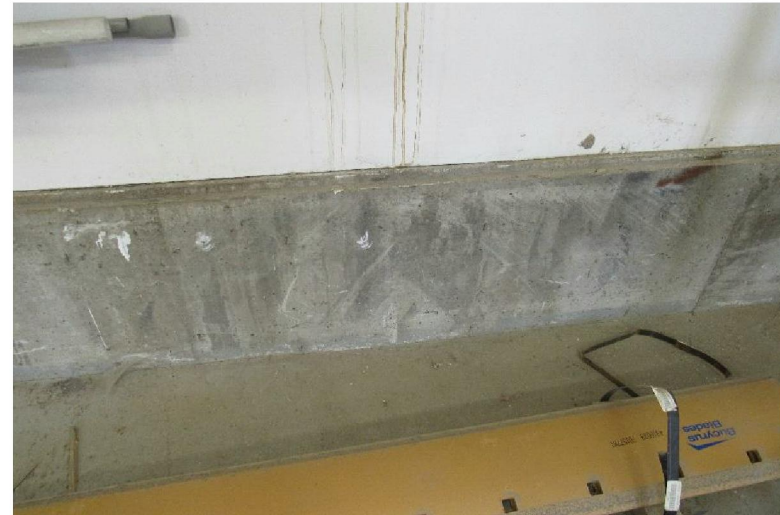
**Photo #S2:** Exposed the South Shop CIP foundation wall.

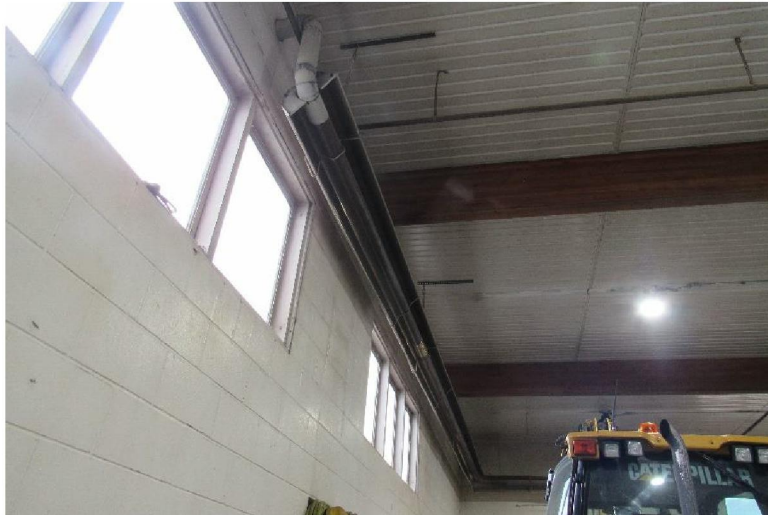
**Photo #S3:** General overview of the exposed metal roof decking and wood structure in the Main Shop.

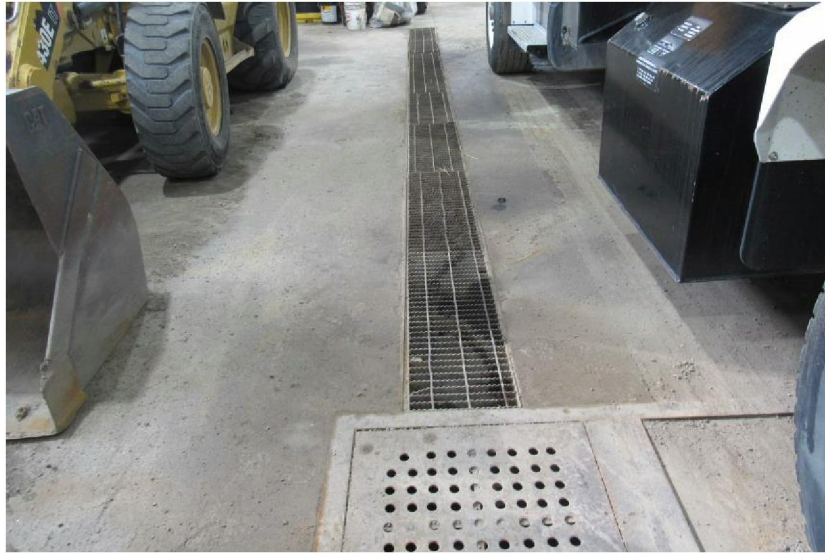
**Photo #M3:** Floor drains in the main shop bay.

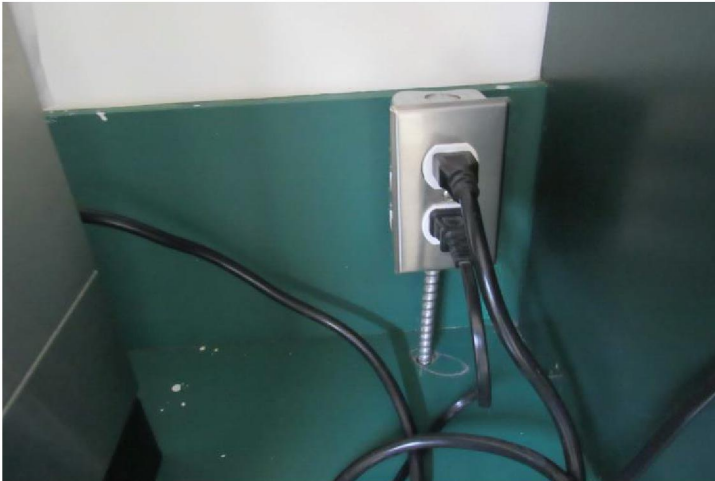
Overall, the electrical components observed in each facility is of acceptable conditions. Immediate action items with respect to non GFCI receptacles are anticipated at this time. Capital expenditures with regards to distribution equipment, lighting, fire alarm and communication, data and security are anticipated within the evaluation period. No additional investigations are not recommended at this time.

**Photo #E7:** Non GFCI receptacle by the break room sink.
