TOWN OF PINCHER CREEK COUNCIL MEETING AGENDA

In the 2021 Lebel Mansion Facility Lifecycle Assessment it was noted (A02.6)

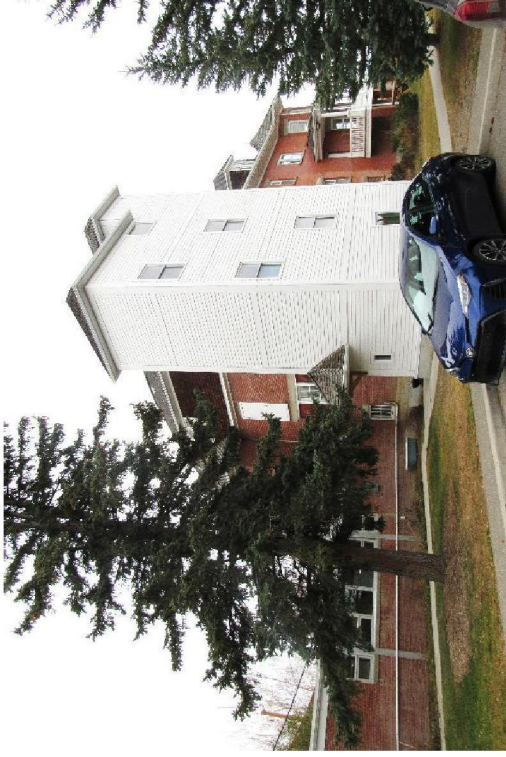
A02.6	Exterior Paint	~2006/2020: Verandah, wood siding, soffits and trim, and the wood windows are typically finished with paint.	3/4	C	The majority of the windows and the stair/elevator tower are showing signs of deteriorated paint. No concerns observed or reported on the verandah or soffits. (See Note 4B).
A02.7	Joint Sealers	~2000: Urethane -based sealants are provided at openings, expansion joints and material transitions.	2	C	Joint sealer appears to generally be missing around penetrations. A cost is included to install new sealant around these sections. (See Note 4B).
A02.8	Louvers	Not present.	-	-	N/A
A02.9	Insulation	~1909: Concealed, but the exterior walls are likely provided with cell fill, batt fiber glass insulation, and/or rigid insulation.	4	-	No concerns observed or reported.
A02.10	Vapour Barrier	~1909: Concealed, but the exterior walls are likely provided with polyethylene vapour barrier where interior GWB is present.	4	-	No concerns observed or reported.

Photo #A6: General view of exterior claddings showing the stair/elevator tower. (Brick masonry, Cedar shakes, Wood panels and Wood sidings).

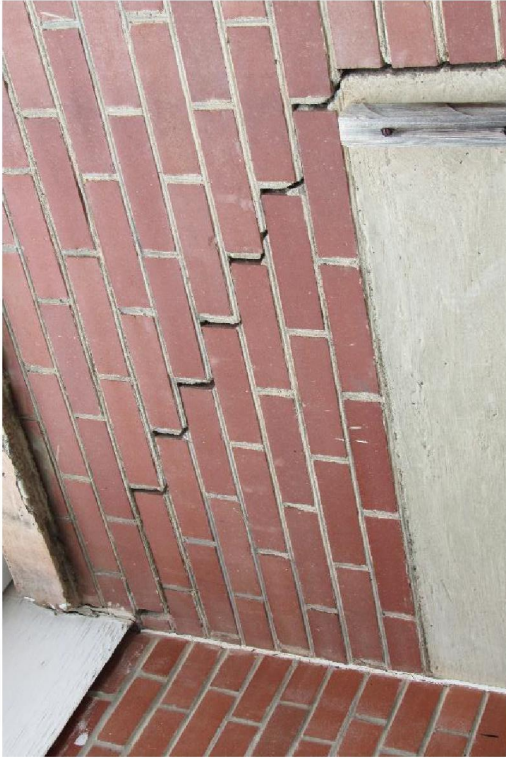
Step cracking of the brick veneer mostly at the top of the windows was observed in the east and west elevation of the main building. Load bearing block wall vertical cracks at the Pottery Studio were observed. We recommend these cracks be filled and sealed to prevent further deterioration.

Photo #A7: Step cracking on the brick masonry.

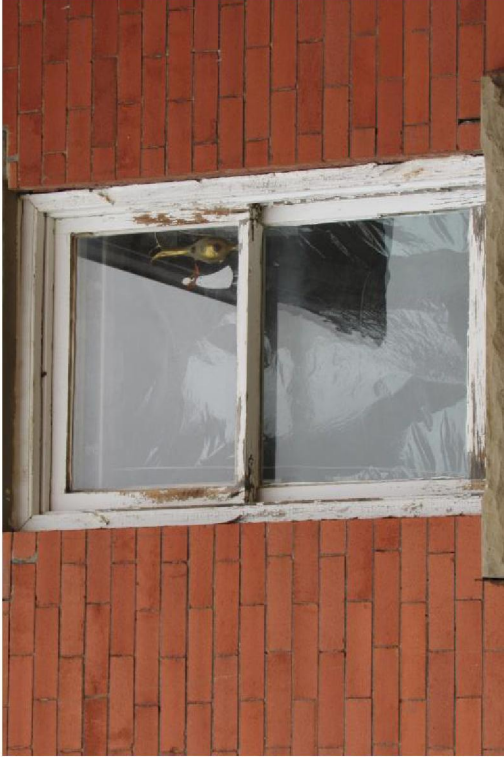
Photo #A9: Current condition of wood windows.

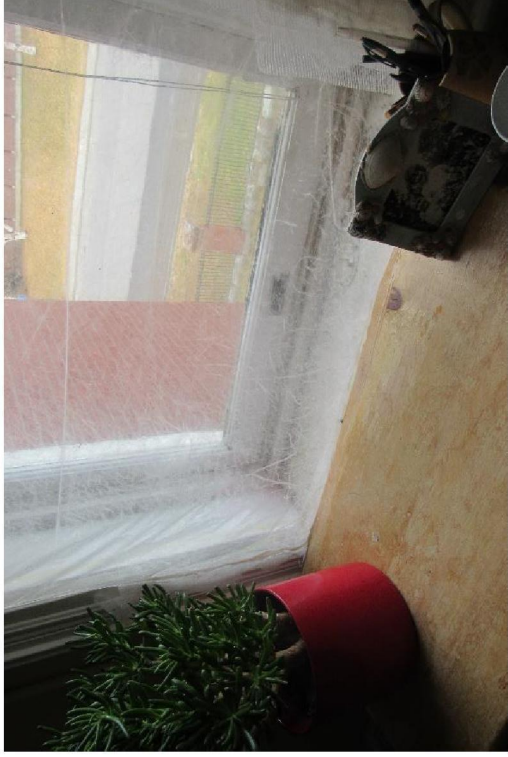
Photo #A20: Window in the room #206 (air infiltration observed).

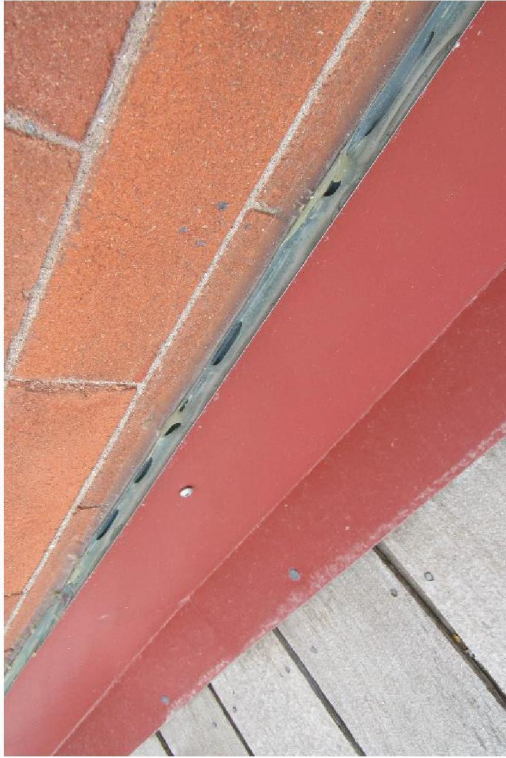
Photo #A23: Joint sealant failure.

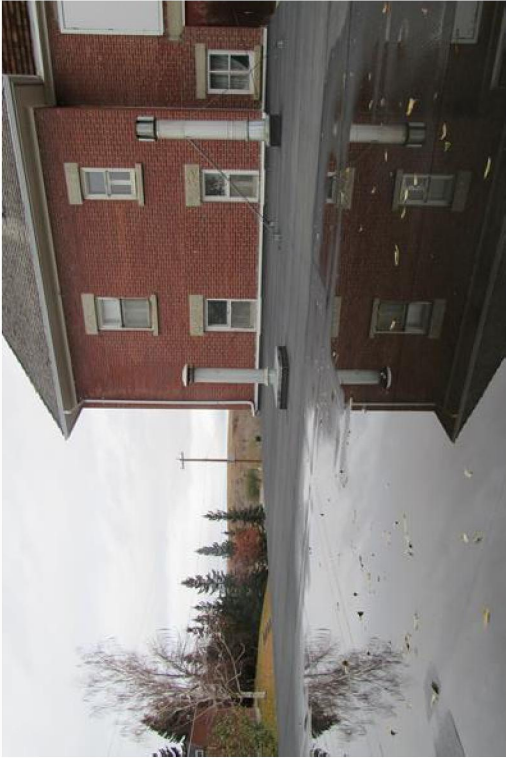
Photo #A25: SBS flat roof (Water pond observed).

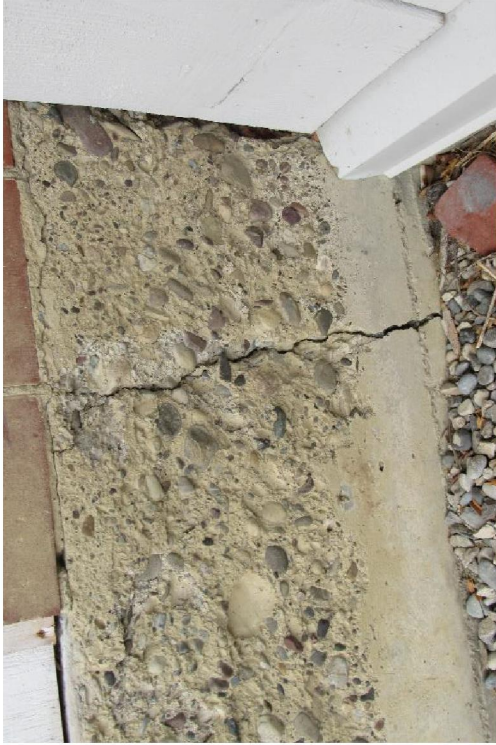
Photo #S1: Crack on foundation wall.

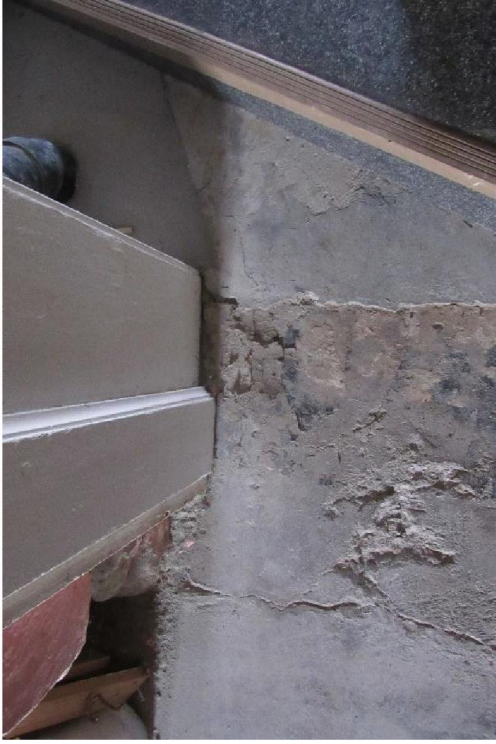
Shrinkage cracks, crazing, concrete spalling, and abraded floor surface were observed in the concrete slab on grade at the main building and we recommend these cracks be filled and sealed to prevent further deterioration and monitored for additional movement. The floor slab at the Pottery Studio is covered with ceramic tiles and structural components could not be viewed. We assumed the floor slab to be consisted of cast-in place concrete slab on grade. No cracks and ground settlement of the floor was observed.

Photo #S2: Cracks and spalling on the SOG.

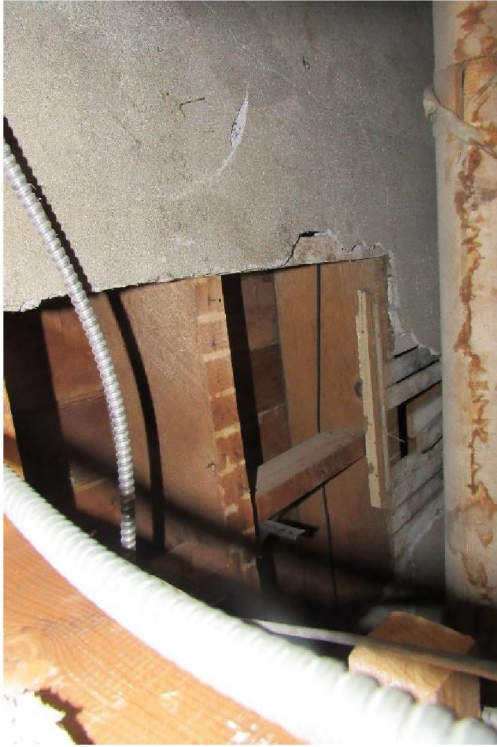
The wood elements in the building are generally in marginal condition. The wood framing for the roof and walls has reached the end of its expected useful life. We recommend a structural study be completed to review the condition of the wood framing in the building.

Photo #S3: Wood framing (joist & studs).

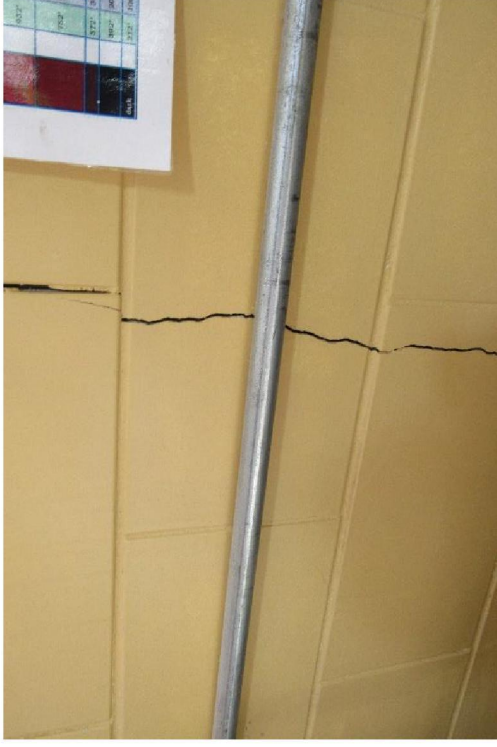
Photo #S4: Vertical cracks in CMU wall in the pottery studio.

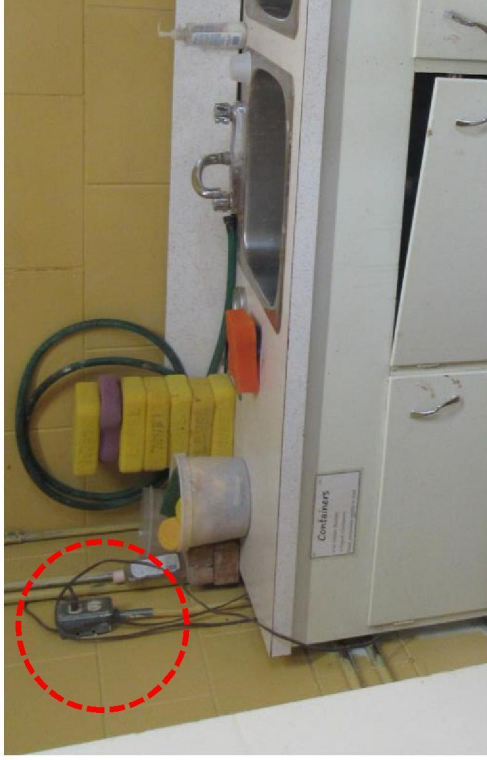
Photo #E5: GFCI receptacle are not installed in pottery studio.

Immediate investigation / action items identified pertain to Installation of GFCI receptacles and cover plates where necessary. Deficiencies and Capital Reserve Items have been identified within the 20-Year time frame of this report with respect to architectural, structural, mechanical and electrical components and systems. The Immediate Repairs and Capital Reserve Analysis are included in Appendix C.

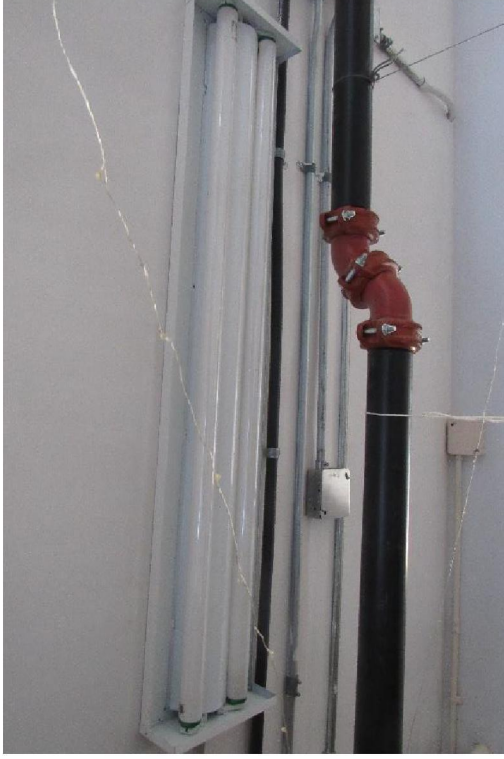
Photo #E6: Typical ceiling-mounted linear fluorescent light fixtures with T12 bulbs.
