**COMMITTEE OF THE WHOLE
MEETING AGENDA**
Wednesday, June 7, 2023 at 9:00 a.m.
Council Chambers, Town Hall
Zoom Link

SUBJECT: Community Recreation Centre - Facility Condition Assessment	
PRESENTED BY: Alexa Levair, Director of Operations	DATE OF MEETING: 6/7/2023

To present council with the results of the Facility Condition Assessment of the Community Recreation Centre located at 942 Hyde Street.

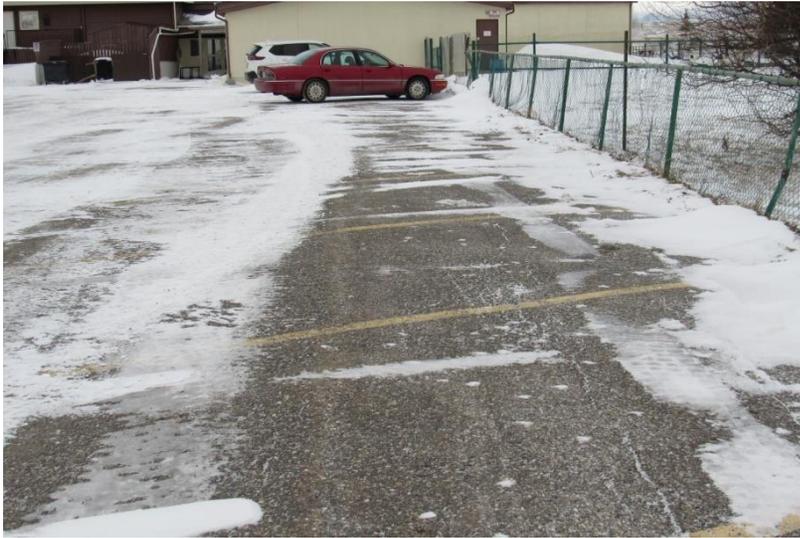
Photo #A1: Asphalt paved parking lot located in the north side of the building.

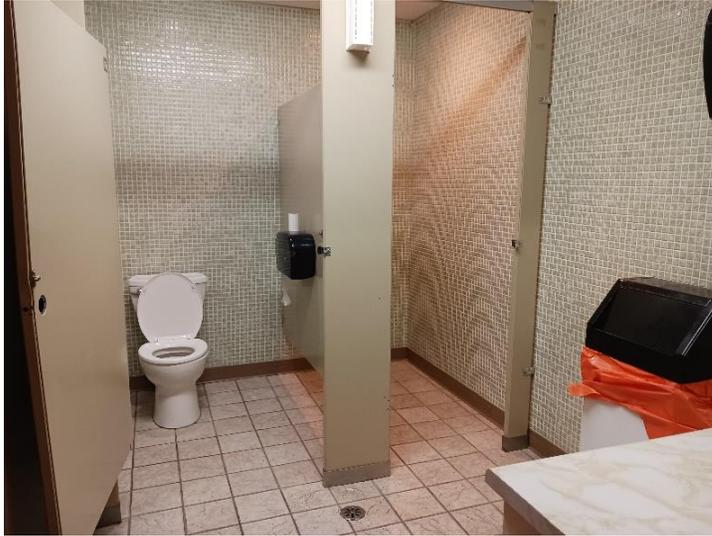
A cursory review was performed regarding the accessibility and barrier free compliance of the buildings. It is observed that the building is largely noncompliant with current standards. Two accessible parking stalls are provided in the parking lot; however, both should be provided with a vertical pole mounted sign and the paved surface is not provided with compliant markings. A wood ramp is provided to the main level of the Golf Clubhouse; however, the railings are non-compliant. The concrete ramp leading to the lower level does not have handrails and appears to be too steep a slope. None of the entry doors are provided with automatic openers. The building is not provided with an elevator and interior stairs do not have compliant handrails, and interior doors have knobs rather than lever hardware. Although some washrooms have some portions of components present, none of the washrooms or changerooms are fully compliant. The stalls do not have required arrangement of grab bars, have doors swing in the wrong direction, and in general are dimensionally too small. Most sinks and drinking fountains do not have proper knee space and the toilet room accessories have wrong mounting heights.

Photo #A13: General interior finishes in Golf Clubhouse Washroom.

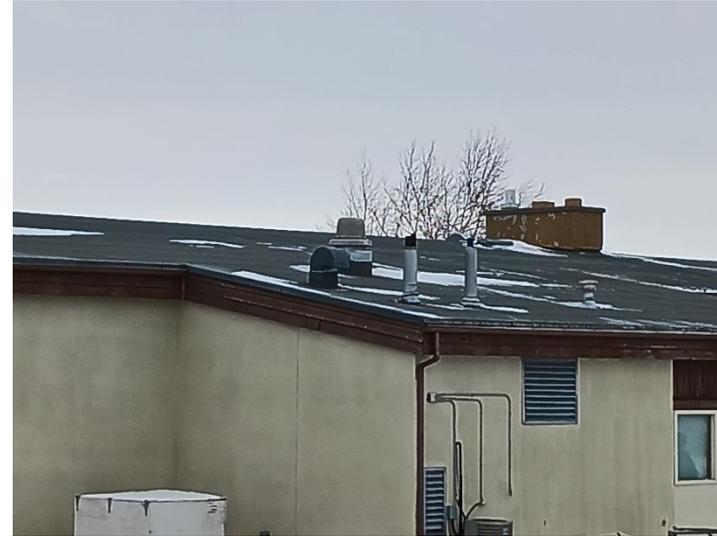
The Golf Clubhouse and Bowling Alley roofs are sloped wood structures finished with SBS roof membrane. The roof of the Golf Clubhouse was reported replaced in 2020. The roof of the Bowling Alley had a major repair in 2007. Water is drained from roof surfaces through gutters and downspouts.

Photo #A14: General view of the Bowling Alley roof.

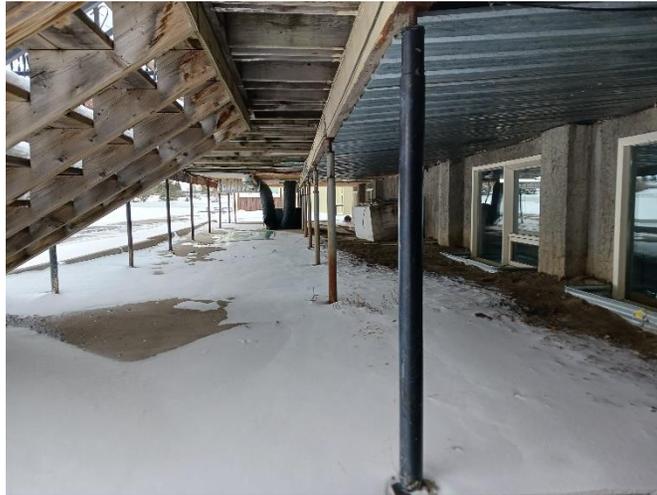
The Golf Clubhouse deck is observed to be wood framed. One sunroom was built on the original deck which is attached to the Golf Clubhouse. It was reported by the management that the deck has a settlement issue. The roof of the Golf Clubhouse is composed of glulam wood beams, the roof decking is concealed but assumed to be wood decking. The roof of the Bowling Alley is concealed but are assumed to be wood framed with wood decking.

The structural components of the Community Recreation Centre are in overall acceptable condition. However, based on the information provided by the management and observation at the time of site, the Golf Clubhouse deck is in poor condition. Capital expenditures with respect to repairs of the Golf Clubhouse deck. No immediate action items have been identified. A structural study for the Golf Clubhouse deck is recommended.

Photo #S1: Deck Support Structure.

RAI.2) Structure study for Golf Clubhouse deck.

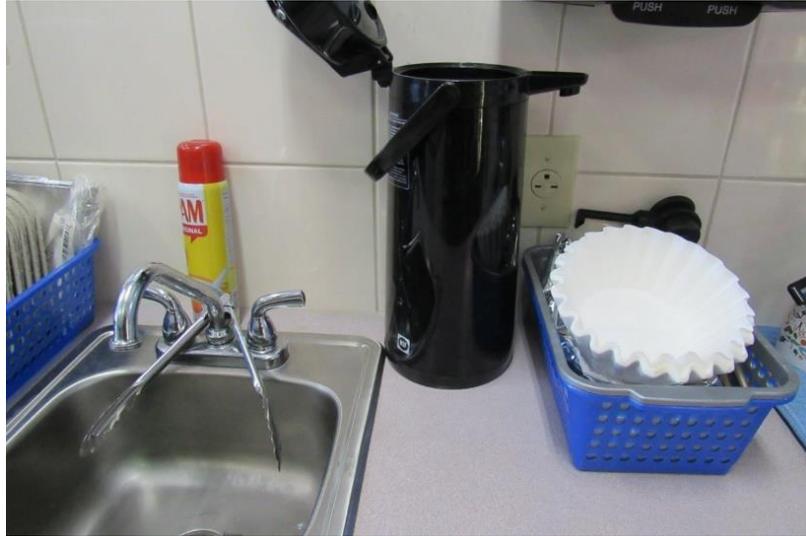
Overall, the electrical components observed in the building is in acceptable conditions. Immediate action items with respect to non GFCI receptacles are anticipated at this time. Capital expenditures with regards to distribution equipment, lighting, fire alarm, and surveillance systems are anticipated.

Photo #E10: Non GFCI receptacle by the break room sink.
