**TOWN OF PINCHER CREEK COUNCIL
MEETING AGENDA
Monday, November 28, 2022 at 6:00 p.m.
Council Chambers, 962 St. John Avenue
Zoom**

Program Plan and Conceptual Design for the Town Hall Expansion

FINAL REPORT

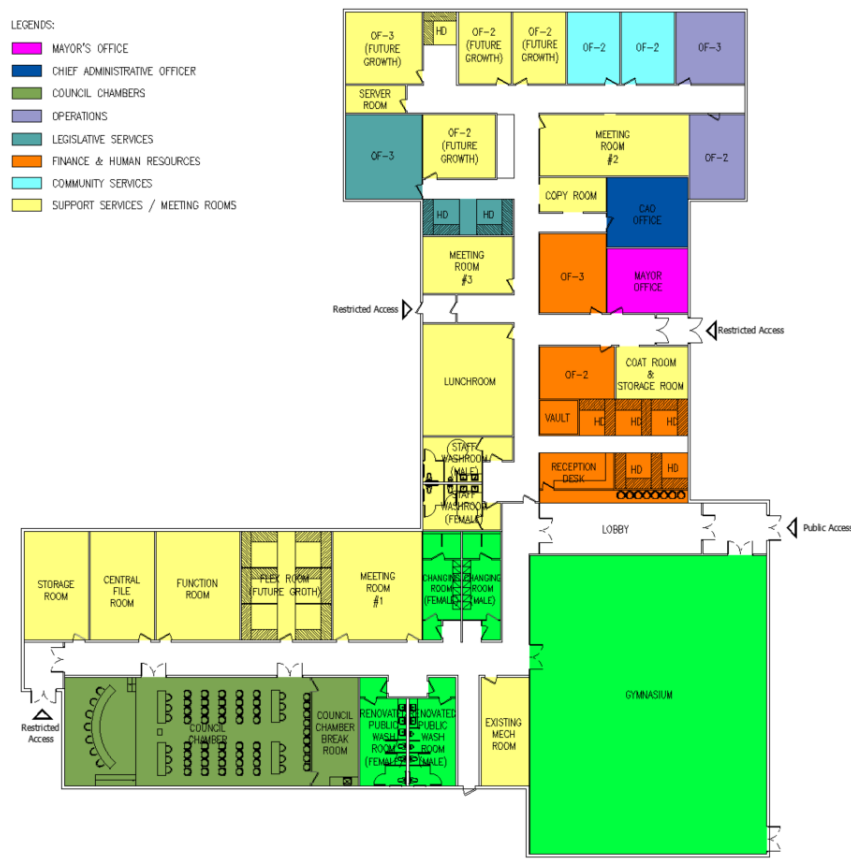
Graphic 1 - Renovated Site Layout (top) and functional blocking (bottom)

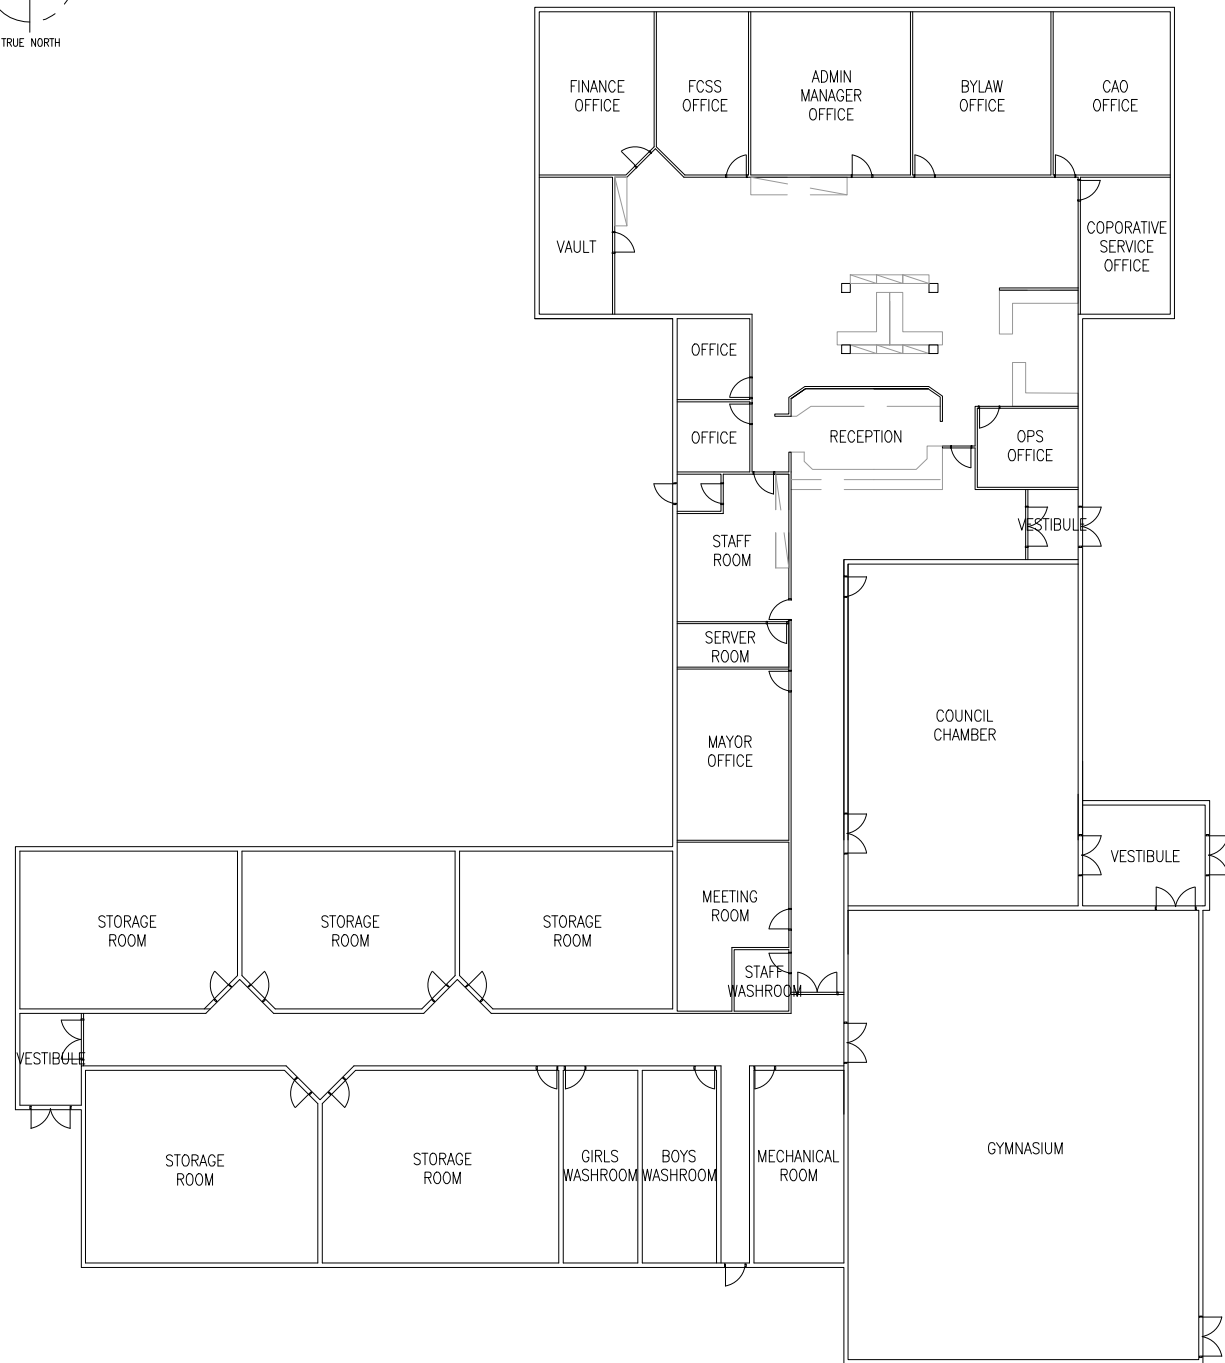
EXISTING FLOOR PLAN

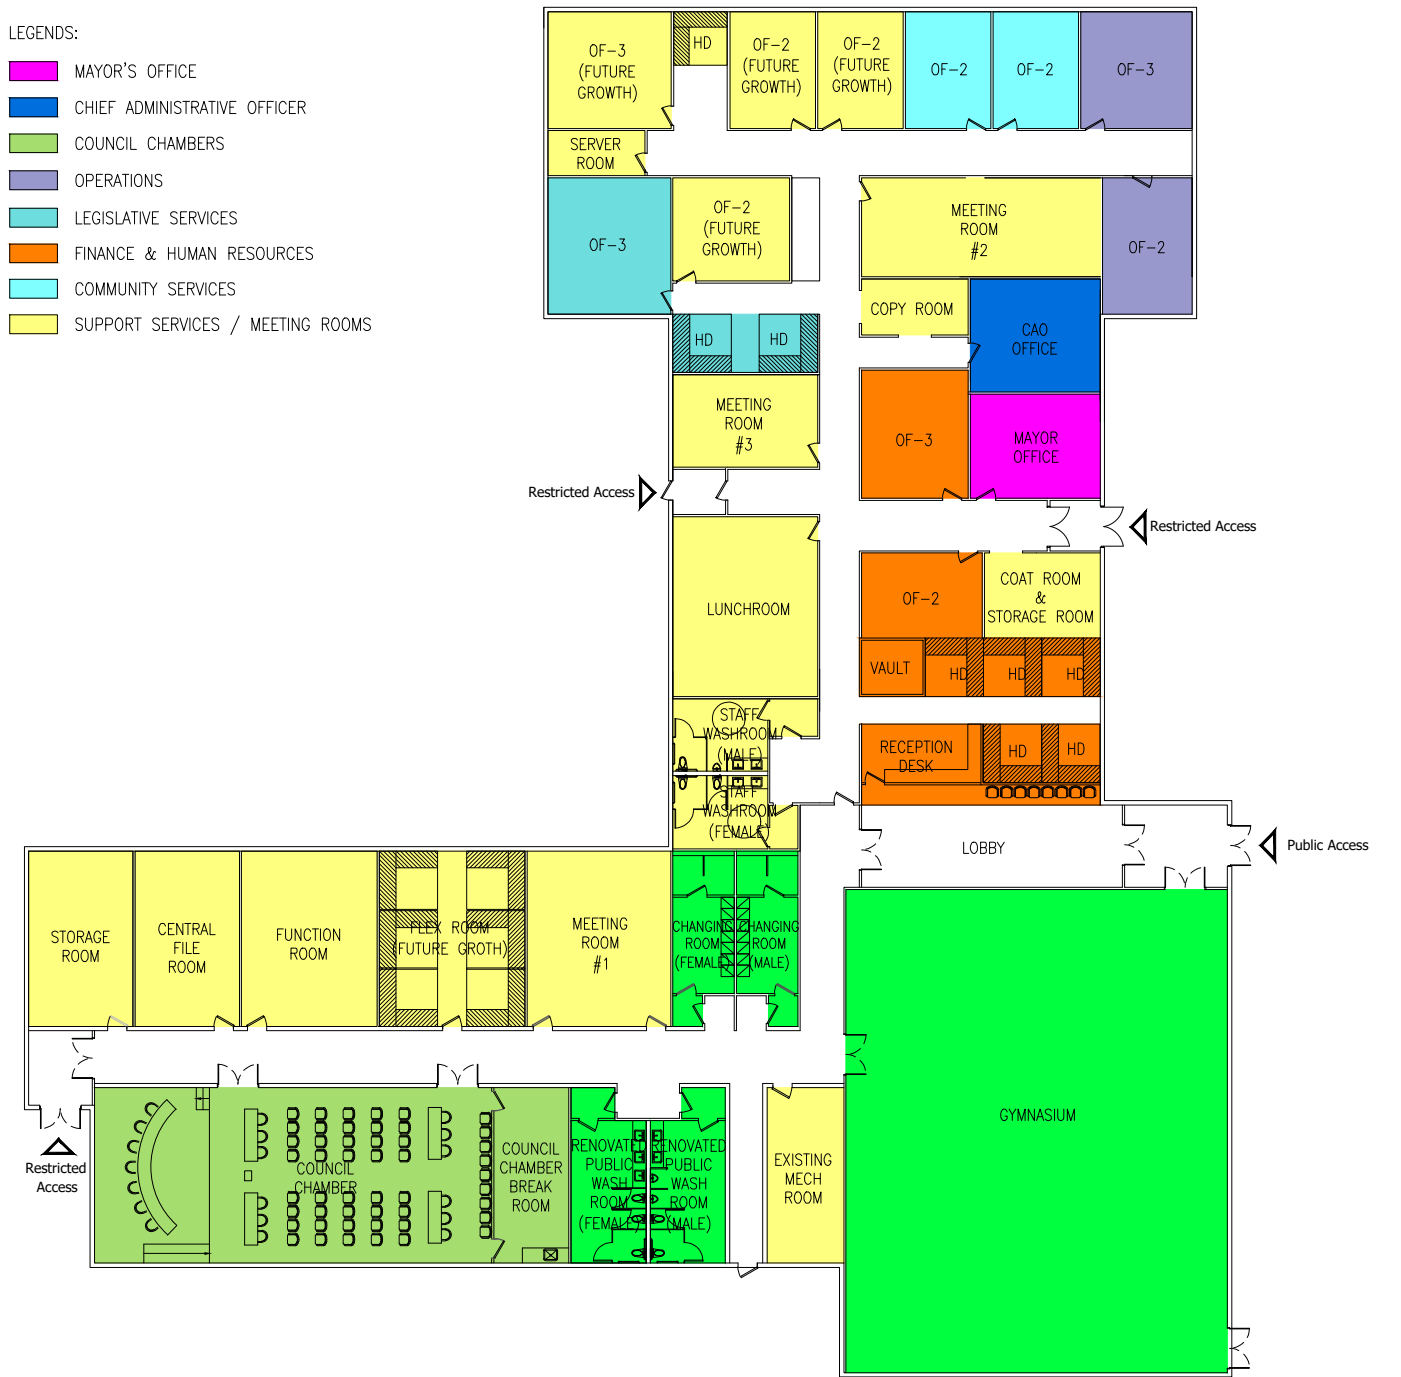
PROPOSED FLOOR PLAN

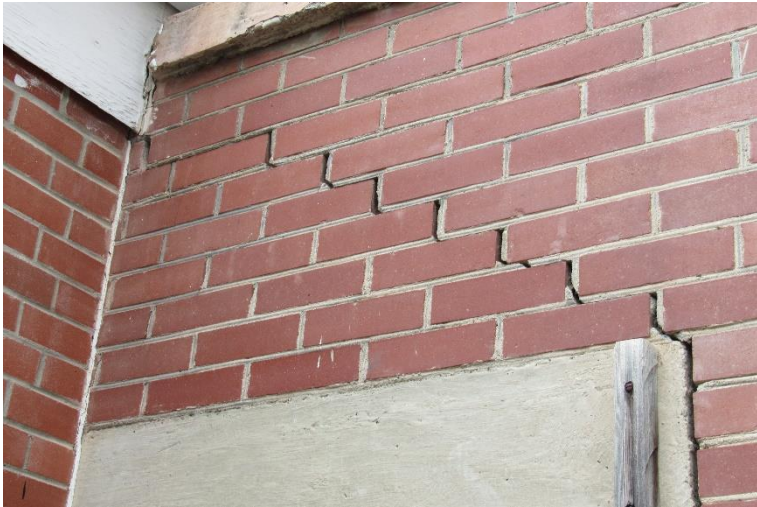
Photo #A7: Step cracking on the brick masonry.

Step cracking of the brick veneer mostly at the top of the windows was observed in the east and west elevation of the main building. Load bearing block wall vertical cracks at the Pottery Studio were observed. We recommend these cracks be filled and sealed to prevent further deterioration.

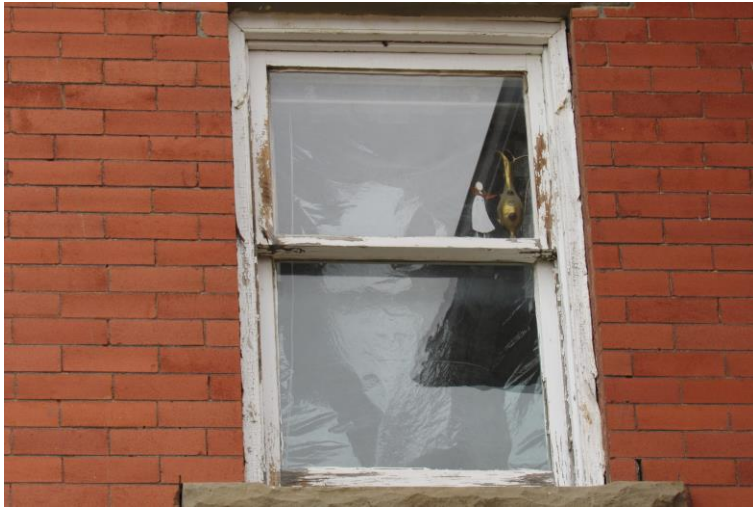
Photo #A9: Current condition of wood windows.

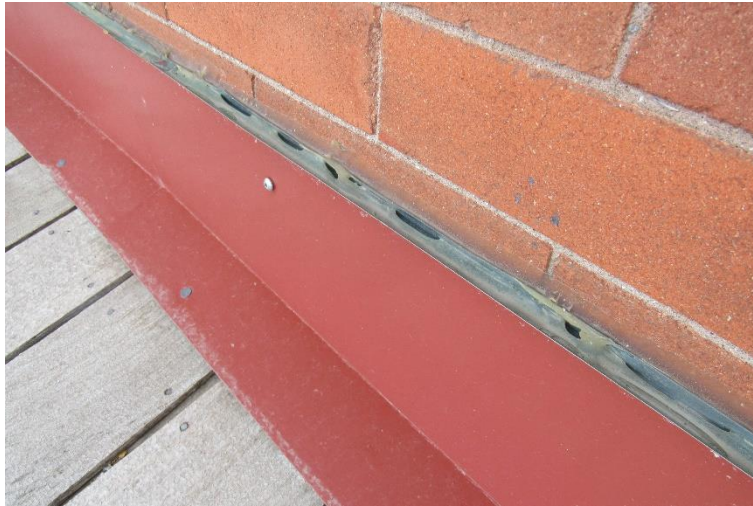
Photo #A23: Joint sealant failure.

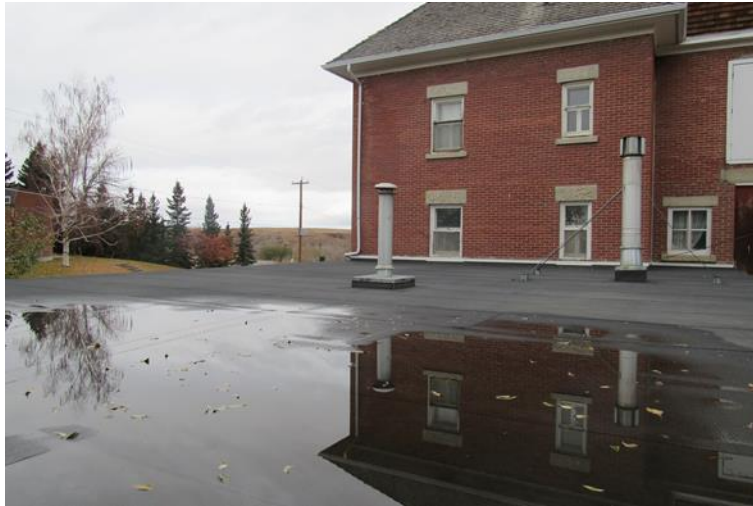
Photo #A25: SBS flat roof (Water pond observed).

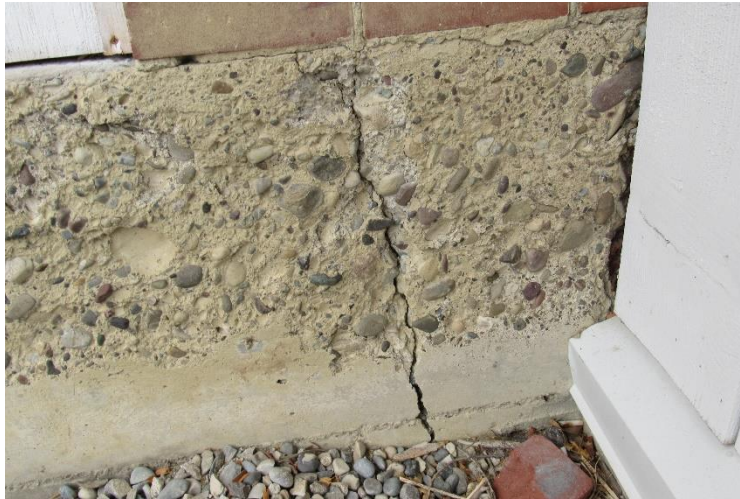
Photo #S1: Crack on foundation wall.

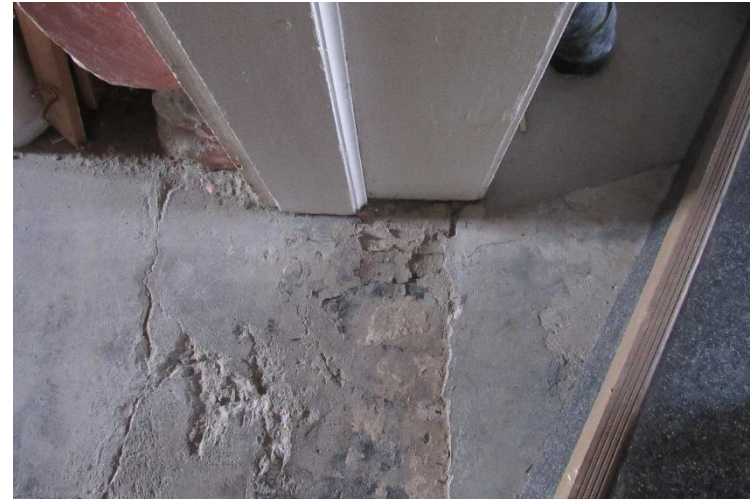
Photo #S2: Cracks and spalling on the SOG.

Shrinkage cracks, crazing, concrete spalling, and abraded floor surface were observed in the concrete slab on grade at the main building and we recommend these cracks be filled and sealed to prevent further deterioration and monitored for additional movement. The floor slab at the Pottery Studio is covered with ceramic tiles and structural components could not be viewed. We assumed the floor slab to be consisted of cast-in place concrete slab on grade. No cracks and ground settlement of the floor was observed.

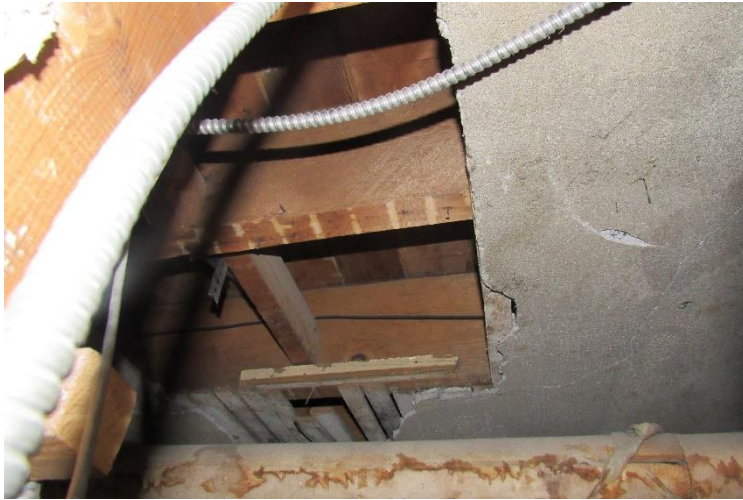
Photo #S3: Wood framing (joist & studs).

The wood elements in the building are generally in marginal condition. The wood framing for the roof and walls has reached the end of its expected useful life. We recommend a structural study be completed to review the condition of the wood framing in the building.

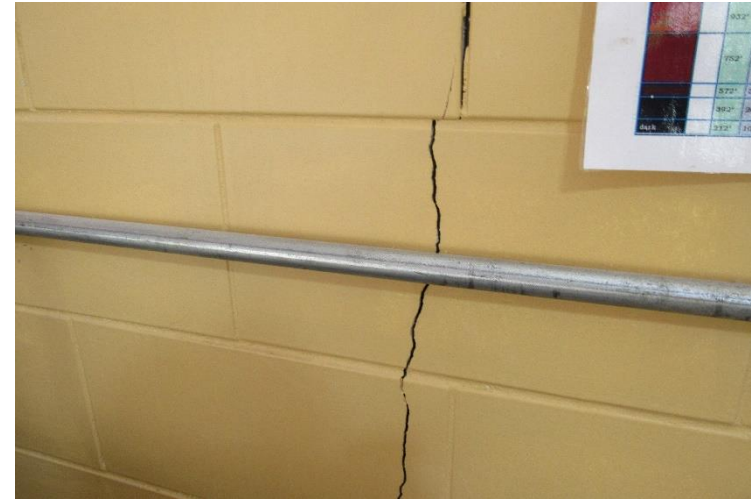
Photo #S4: Vertical cracks in CMU wall in the pottery studio.

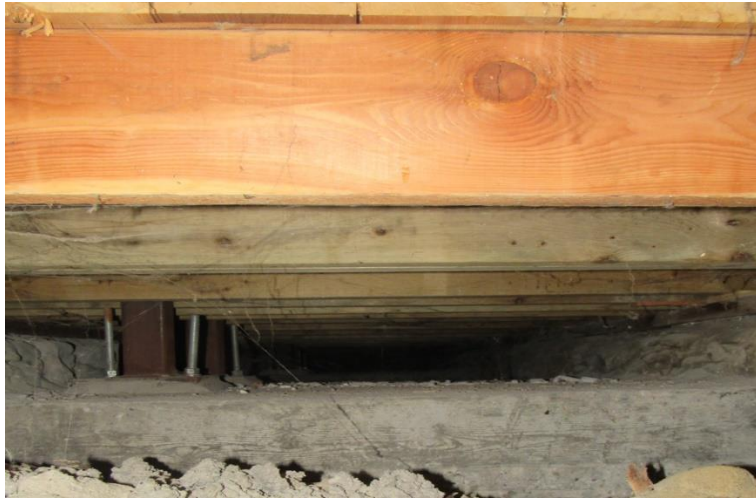
Photo #S5: Suspended floor in the art studio of the basement.

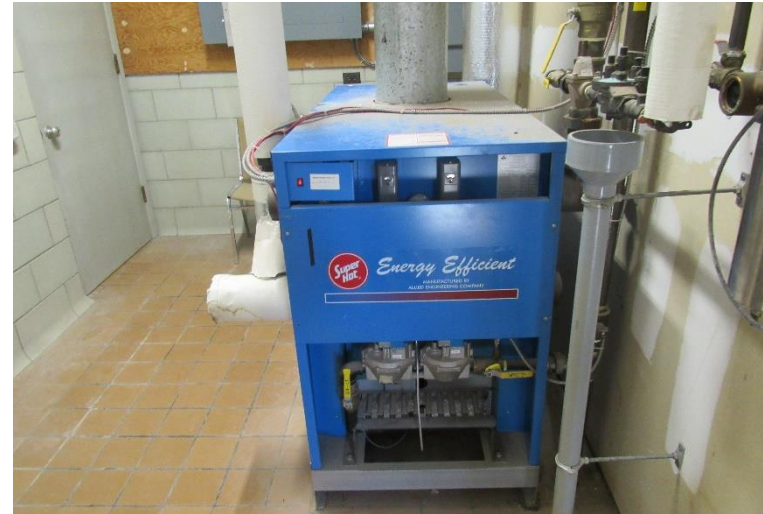
Photo #M4: Gas fired boiler.

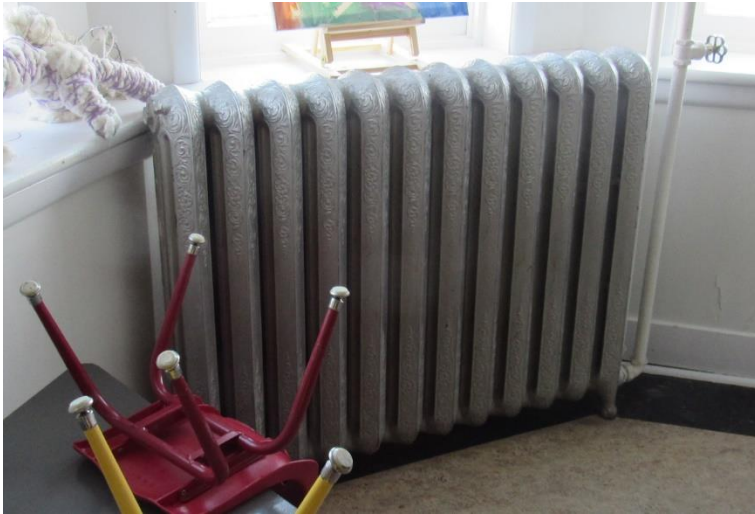
Photo #M5: Typical original hydronic radiant wall heater.

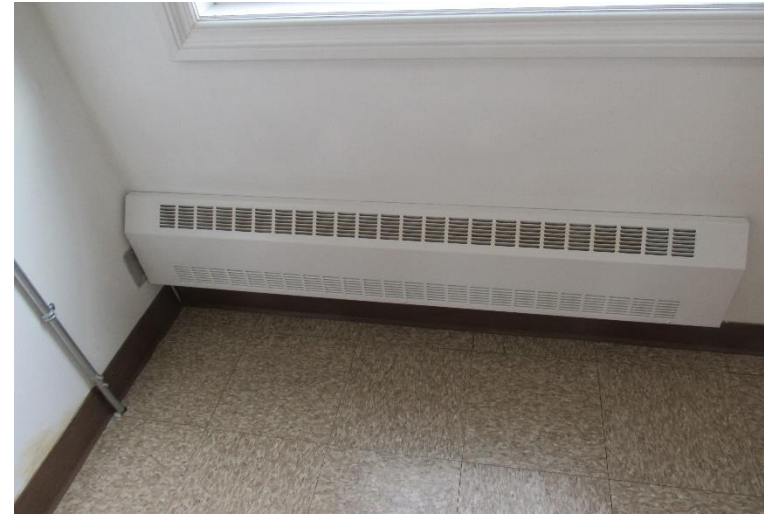
Photo #M6: Typical electric wall heater.

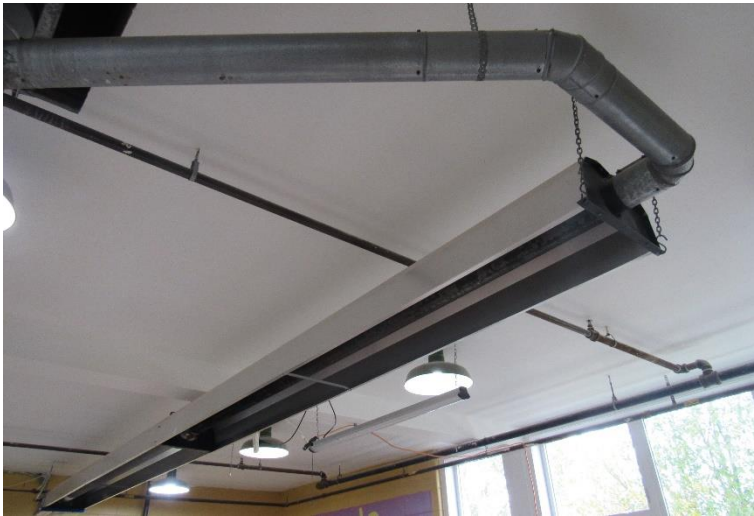
Photo #M7: Gas-fired infrared radiant heater.

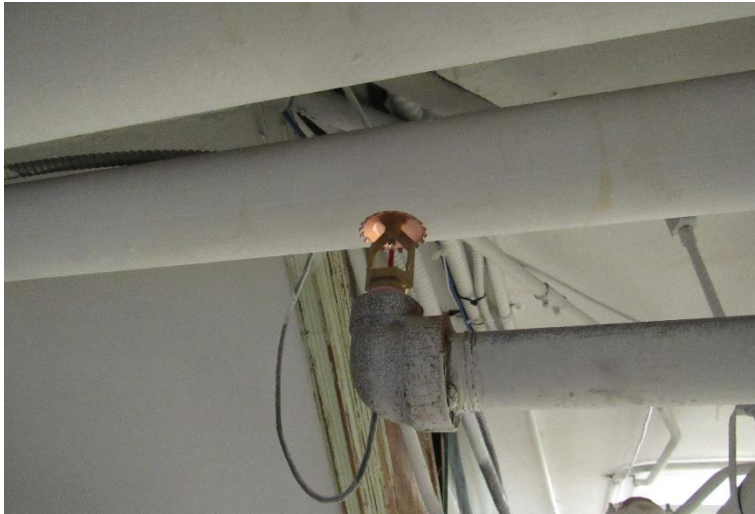
Photo #M9: Typical sprinkler head.

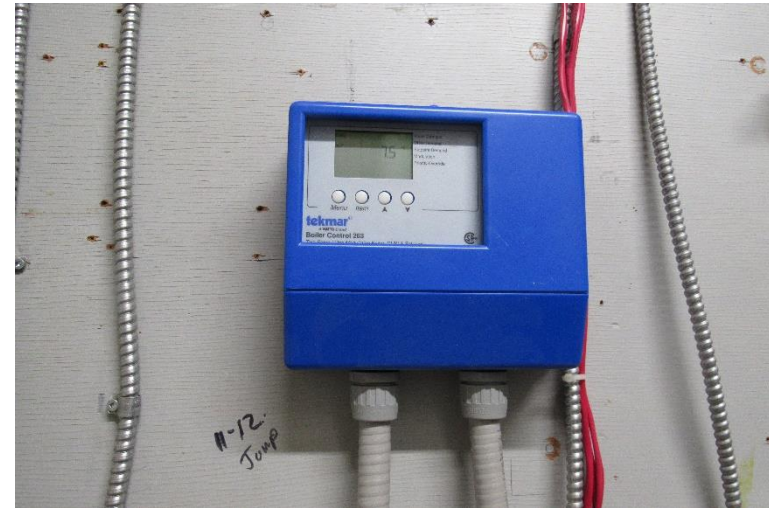
Photo #M10: Tekmar boiler controller.

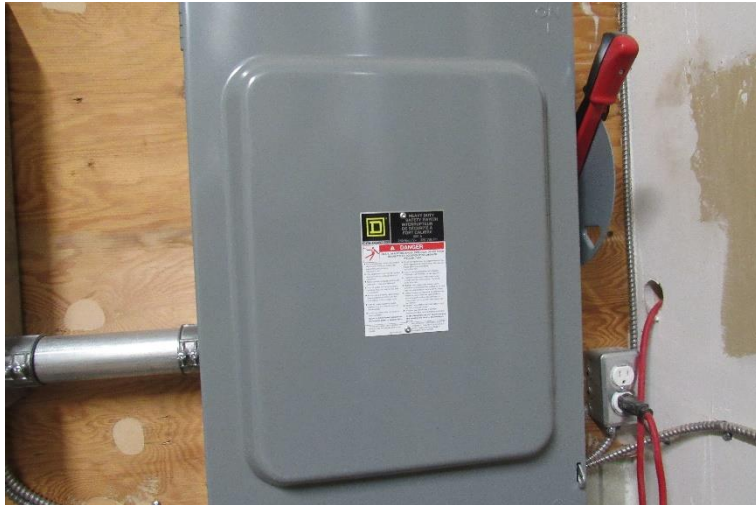
Photo #E1: Main disconnect switch in mechanical room.

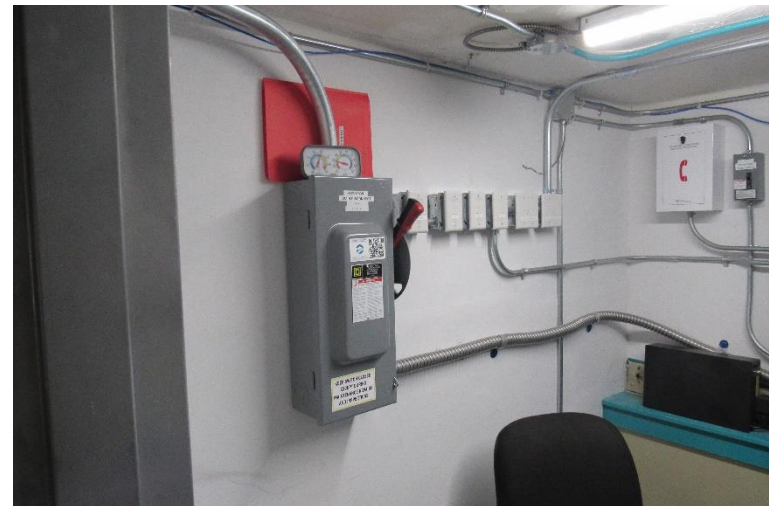
Photo #E4: Disconnect switch in elevator mechanical room.

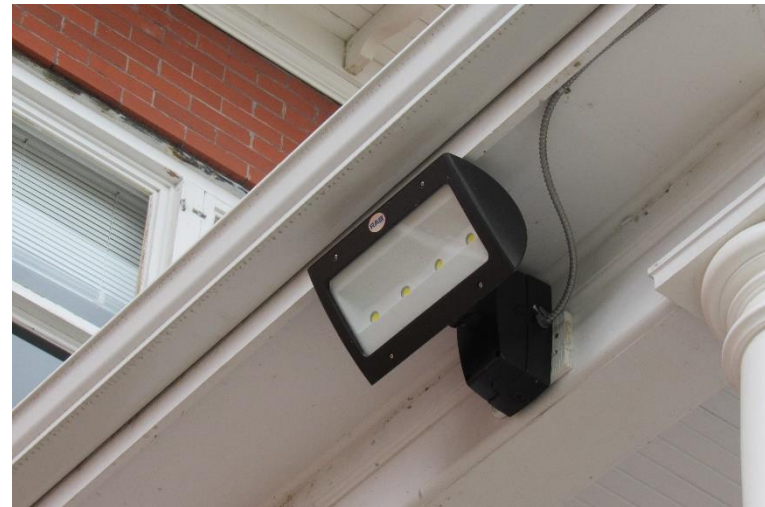
Photo #E8: Wall-mounted LED exterior light fixture.

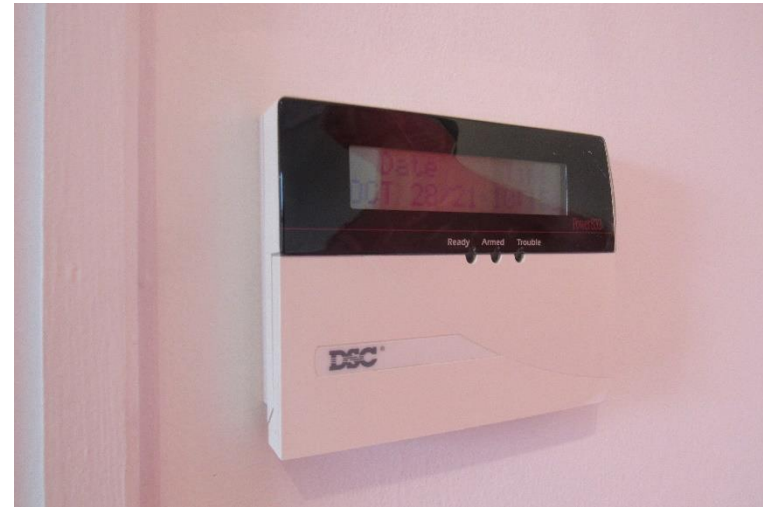
Photo #E12: Intrusive system control panel.
