TOWN OF PINCHER CREEK COUNCIL MEETING AGENDA

In the 2021 Lebel Mansion Facility Lifecycle Assessment it was noted (A02.6)

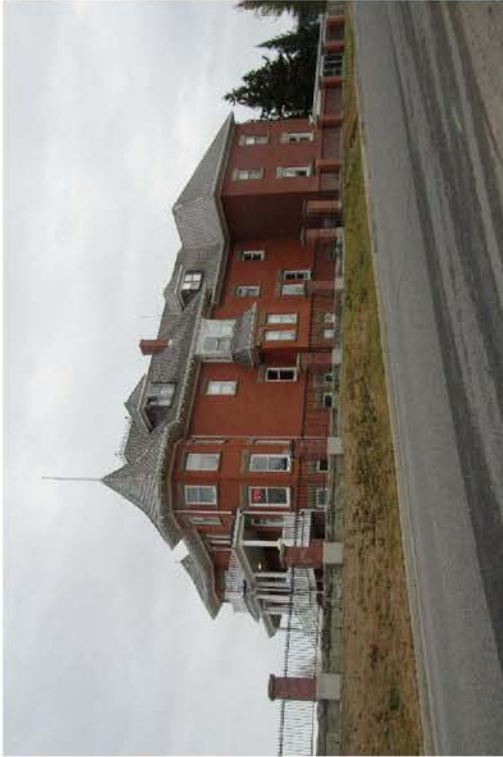
| I.D.# | SYSTEM/COMPONENT | DESCRIPTION | CR | Cat. | COMMENTS/ASSESSMENT |
|---|---|--|---|---|--|
| A02.1 | Brick Masonry Units | ~1909/1924: The exterior walls of the building are primarily constructed of Brick masonry units. | 4 | C | Generally, the brick masonry appeared in acceptable condition. Efflorescence and loose mortar joints were observed at numerous locations. Step cracking was observed in the masonry wall mostly above the windows. Looking inside the building, no apparent sign of water infiltration was noted. We recommend mortar be reinserted between the brick masonry units and repairing areas where damage was observed in the next 2 years to maintain adequate bonding between the individual units, preserve the wall integrity and prevent water infiltration. (See Note 4B). And it is recommended the step cracking be filled and sealed within the next 2 years to prevent further deterioration. This work can be completed as part of routine maintenance. (See Note 4A). |

Photo #A1: General view of Exterior cladding.

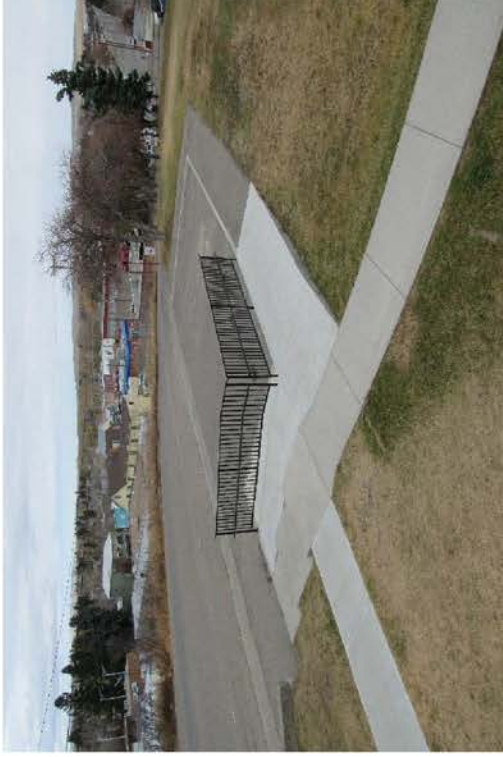
| I.D# | SYSTEM/COMPONENT | DESCRIPTION | CR | Cat. | COMMENTS/ASSESSMENT |
|---|---|---|---|---|---|
| A01.2 | Parking Lots & Drive Aisles | ~1985: The parking lot and drive aisles are finished with asphalt pavement. | 4 | C | It is reported that repairs have been made as needed since it was replaced in 1985 and no issues were observed at the time of the assessment. The asphalt pavements are observed to be in acceptable condition and are expected to be replaced within the time frame of this report. (See Note 4B). |
| A01.4 | Concrete Sidewalks | <p>~1985: The sidewalk on the south and west sides of the property entrance is constructed of conventionally reinforced CIP concrete sidewalks.</p> <p>~2020: The sidewalk in front of the property entrance is constructed of conventionally reinforced CIP concrete sidewalks.</p> | 4 | C | Minor cracks were observed; however, the sidewalks were observed to be in serviceable condition. Replacement of 1985 section of concrete sidewalks is recommended within the time frame of this report. (See Note 4B). |

Photo #A2: North parking lot & Concrete sidewalks and ramps.

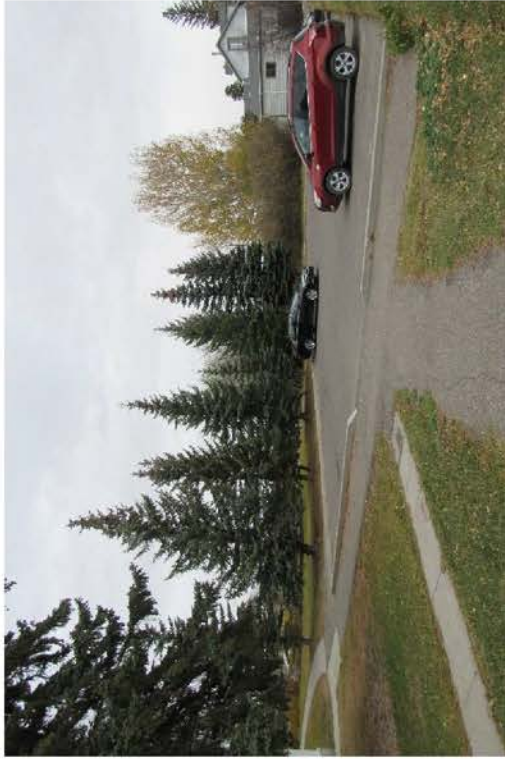
Photo #A3: South parking lot and landscape area.

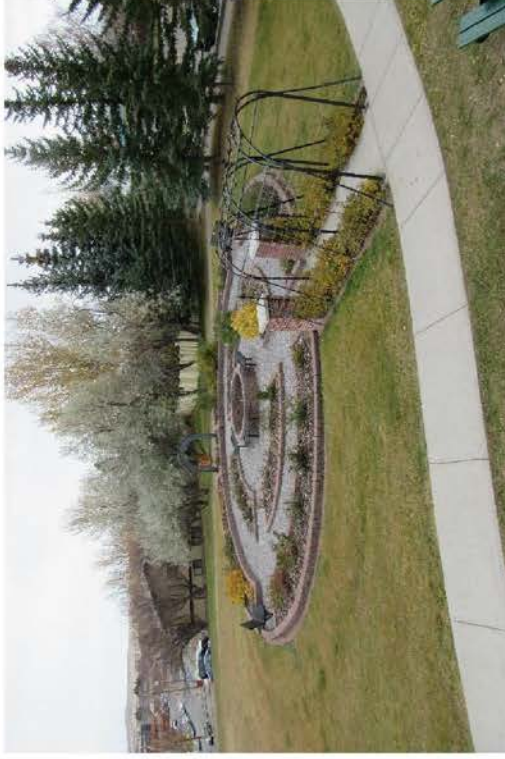
| A01.12 | Amenities - Site Furnishing | -2014: The 48-foot radius rose garden is provided on the east side of property. Circular beds of brick, walkways and wrought iron benches included. | 4 | - | No concerns observed or reported. |

Photo #A4: Overview of the Rose garden.

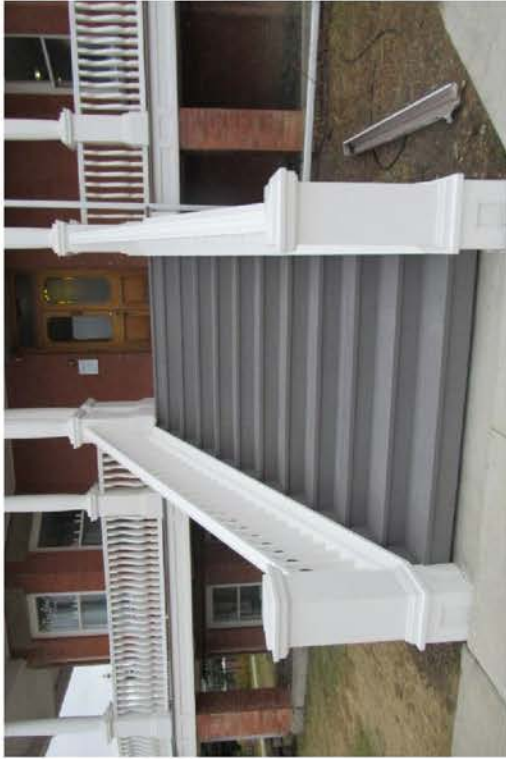
| A01.13 | Exterior Stairs | -2020: Wooden exterior staircase provides access to the verandah located on north elevations of the building. | 4 | - | No concerns observed or reported. |

Photo #A5: Exterior wood stair and main entrance.

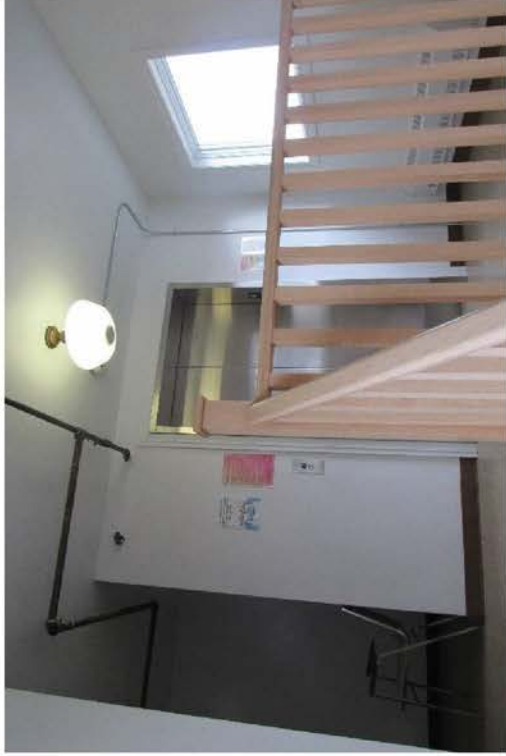
| I.D.# | SYSTEM/COMPONENT | DESCRIPTION | CR | Cat. | COMMENTS/ASSESSMENT |
|---|---|--|---|---|--|
| A02.4 | Wood siding | ~2006: Painted wood siding is provided in the new stair/elevator addition. | 4 | B | The paint appears to be failing and the wood is showing some signs of localized damage. This repair work can be completed at a cost below the threshold. (See Note 4A). |

Photo #A14: Interior finishes of the Stair/elevator addition.

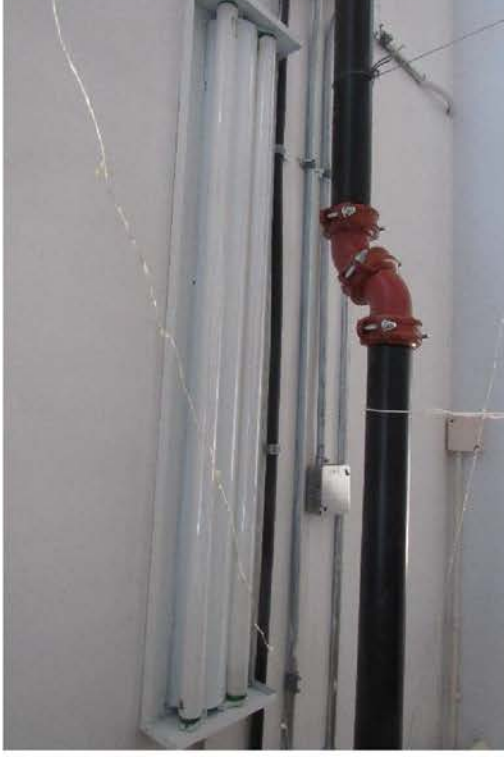
Photo #E6: Typical ceiling-mounted linear fluorescent light fixtures with T12 bulbs.

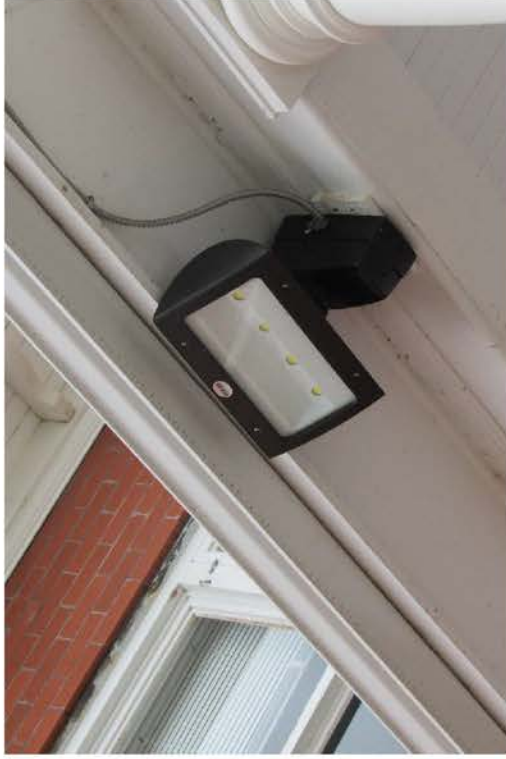
Photo #E8: Wall-mounted LED exterior light fixture.

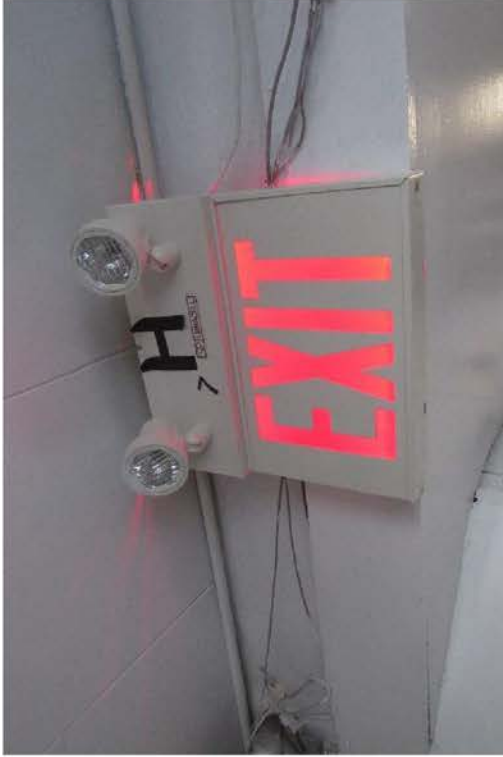
Photo #E9: Emergency battery pack lighting and Exit sign.

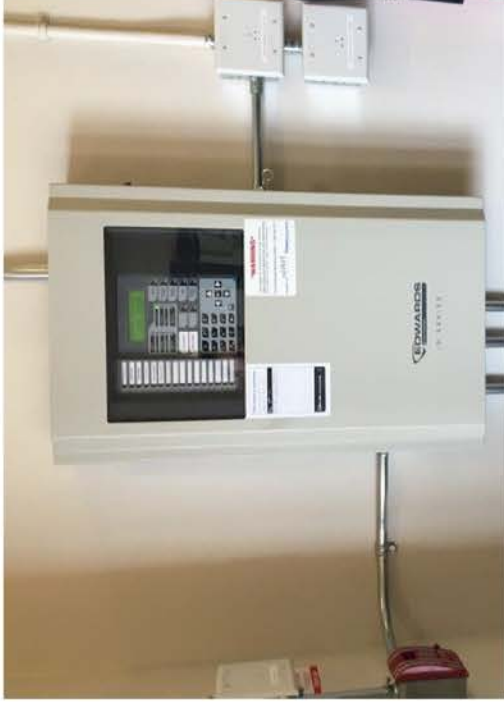
Photo #E10: Fire alarm panel.

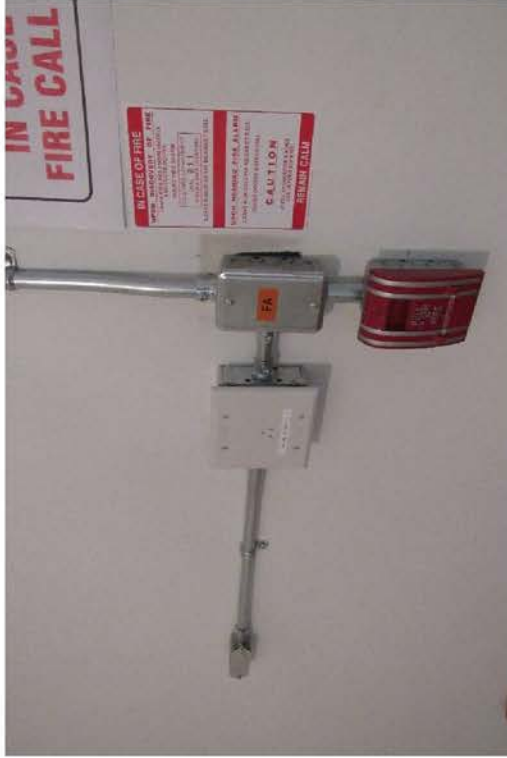
Photo #E11: Typical fire alarm device.

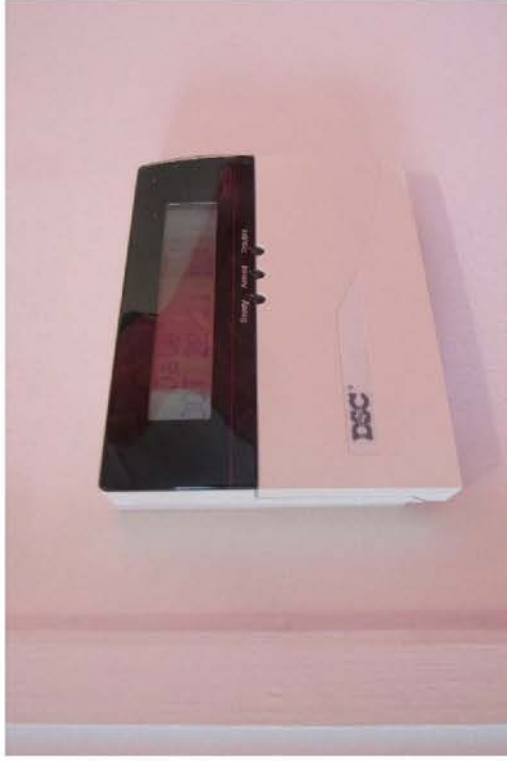
Photo #E12: Intrusive system control panel.

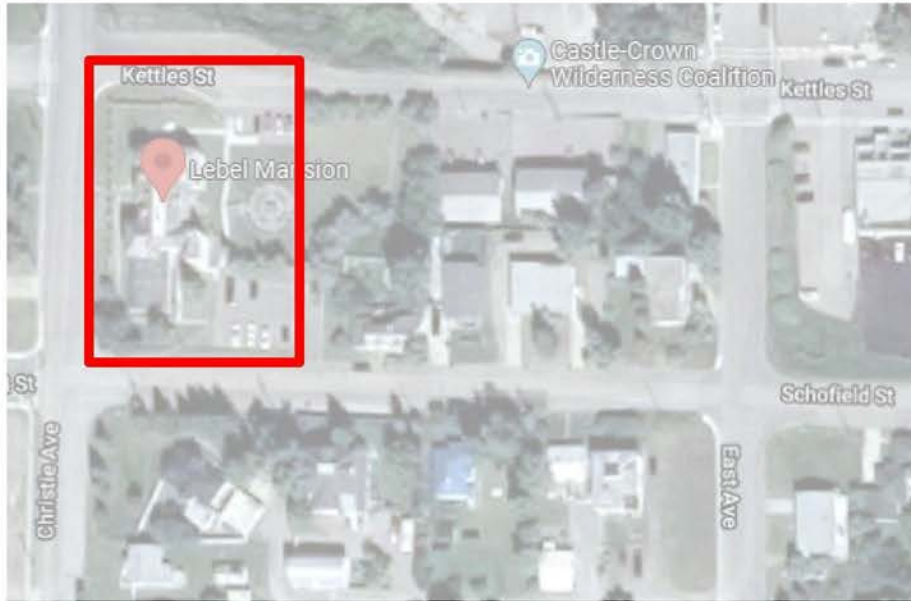
This main building is referred to as the Lebel Mansion of Pincher Creek (Refer to Photograph #1). The attached Pottery Studio is located at the south side of the building facing Schofield Street (Refer to Photograph #2). The Pottery Studio is a single-storey wood framed structure with a gross footprint of approximately 50ft x 20 ft.

Photograph # 1 - General View of the Lebel Mansion - Image from Google Maps

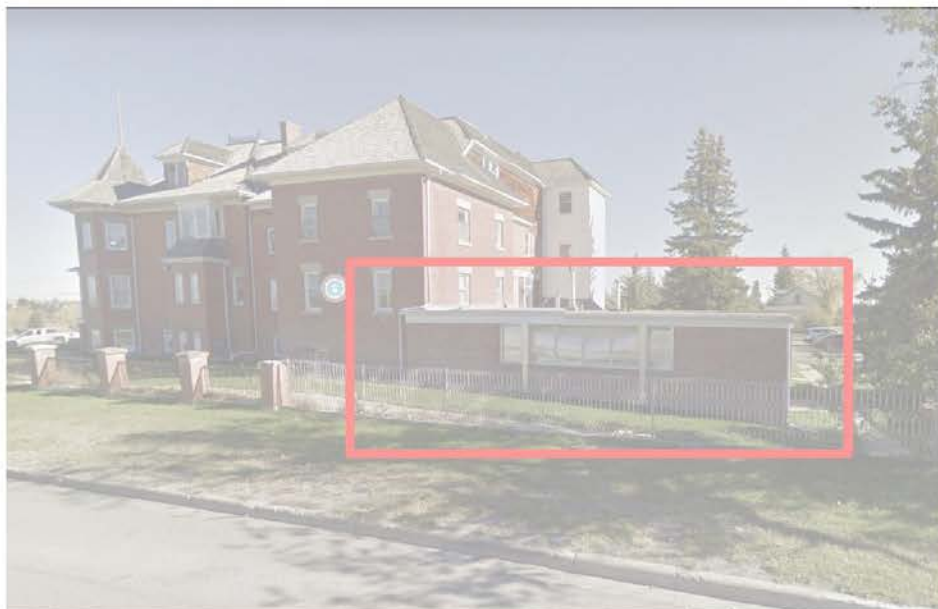
Photograph # 2 - General View of the Pottery Studio - Image from Google Maps

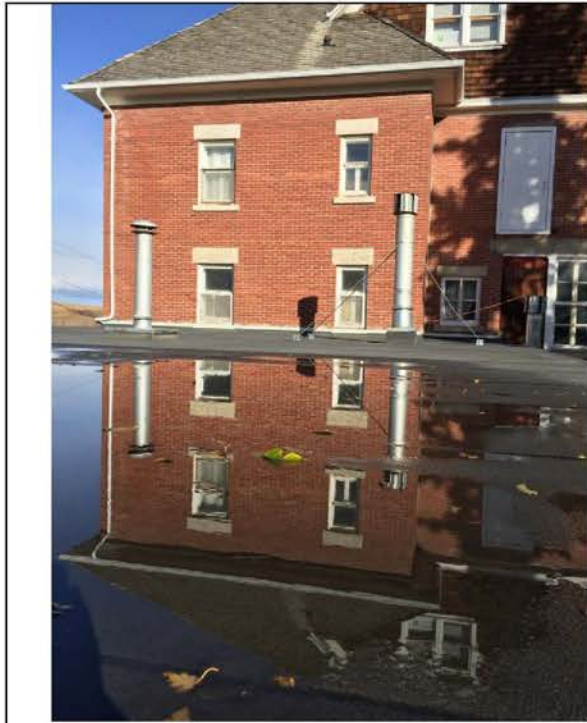
Photo #3

- The Pottery Studio roofs appears to be constructed of flat roof Built Up Roofing System with no parapet all around (Refer to Photograph# 3).
- The roof framing appears to be constructed of T&G wood deck on 2x10 @ 16" o.c. wood joist spanning at 14ft (Refer to Photograph# 4).
- The wood joists are supported by W16 steel beams spanning 20ft supported by steel or wooden posts at both ends.

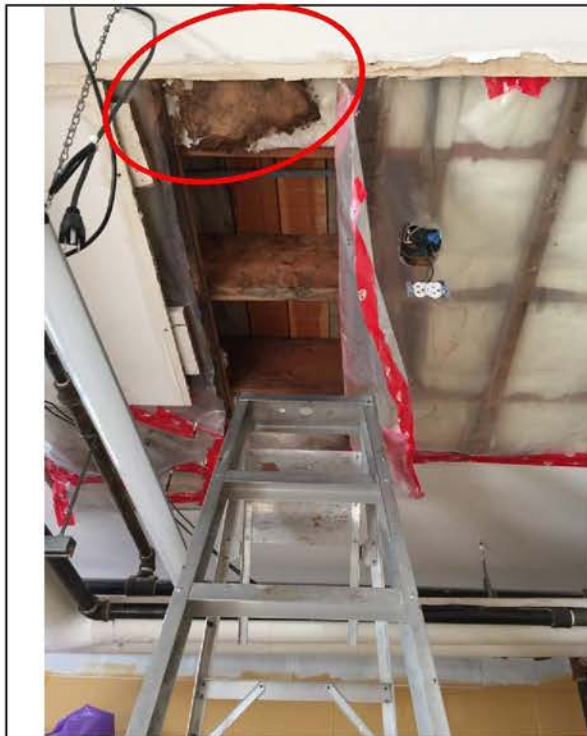
Photo #5

Majority of the roof framing was closed in by architectural finishes and could not be viewed throughout the building during our site visit. The framing was viewed only through small opening prepared by the staff. There was a stain which is a possible water leakage (Refer to Photograph #5). During the site visit, it was difficult for us to assess if the stains were caused by the leakage from the roof or from condensation of mechanical equipment. We recommend conducting thorough visual inspection while completing the installation of the new structural framing for the new solar panel to determine the actual condition of the existing roof framing and provide repairs or replacement if found necessary.
