# TOWN OF PINCHER CREEK COUNCIL MEETING AGENDA

Monday, May 9, 2022 at 6:00 p.m.

# FINAL REPORT

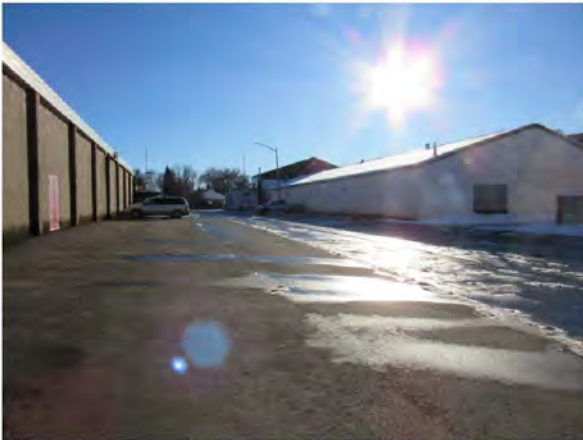
Photo #A1: Site parking lot.

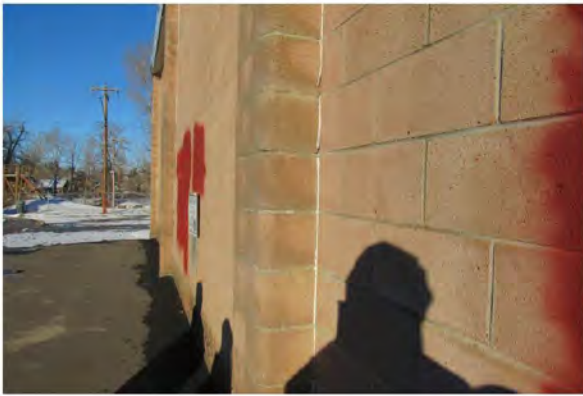
**Photo #A7:** Disconnected Joint Sealers on the exterior wall.

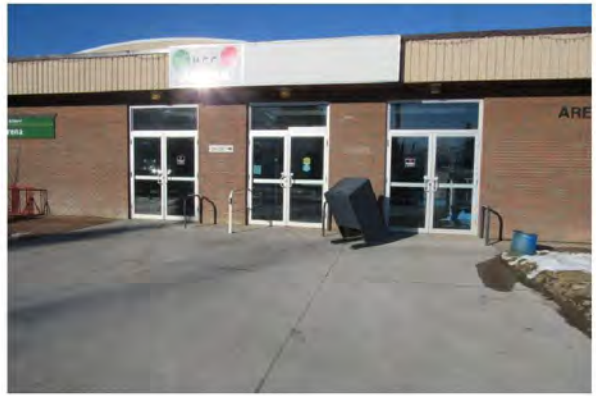
**Photo #A10:** Building main entrance.

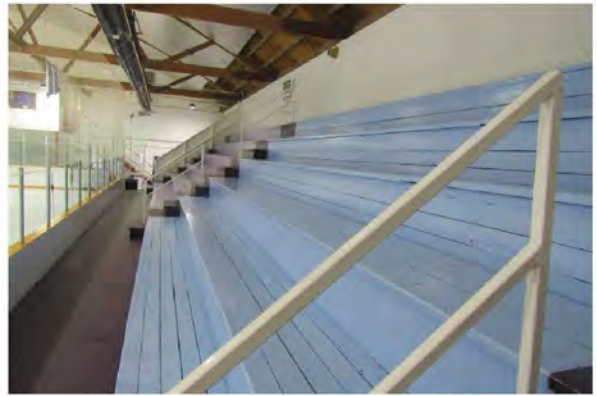
**Photo #A12:** Metal railings and painted bleachers in the rink.

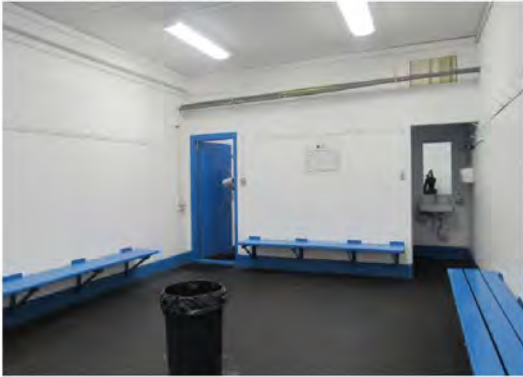
**Photo #A13:** Change room finishes.

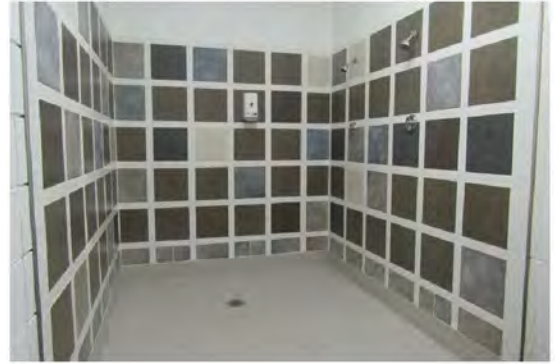
**Photo #A14:** Ceramic wall and floor tiles in change room shower area.

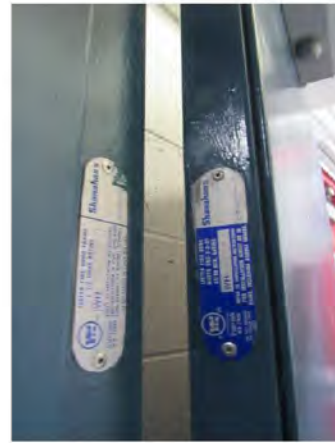
Photo #A16: Interior fire rated door.

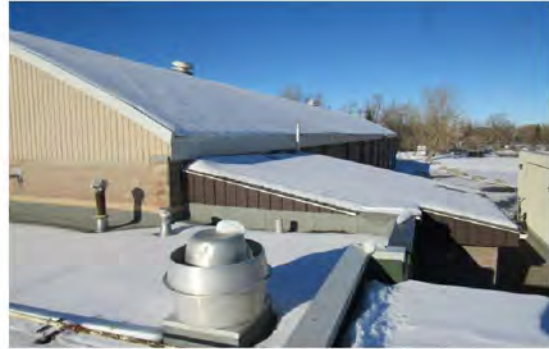
**Photo #A20:** Cap flashing and SBS arched roof and asphalt shingle sloped roof.

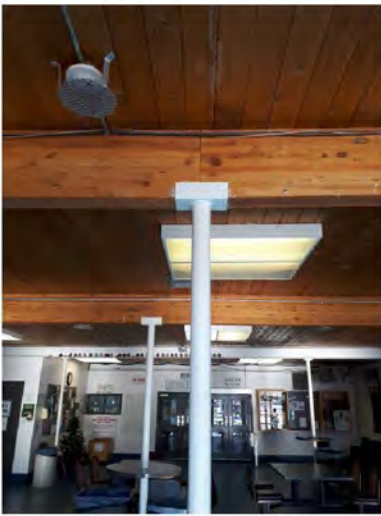
The wood joists form the flat roof over the Lobby and office space. In the Lobby area wood beams and round steel columns were provided to replace load bearing walls. The mono-pitched roof on the east side of the main building is also formed with wood joists. The roof over the arena is formed by 120'-0" span wood trusses with a curved top chord. Wood purlins span between trusses which supports the roof sheathing, deck and insulation. Diagonal cross bracings are provided in alternate bay between trusses. Connection of trusses to the walls and steel plates and bolts used as connecting members was observed.

**Photo #S1:** Wood Beam-Steel Column in Lobby.

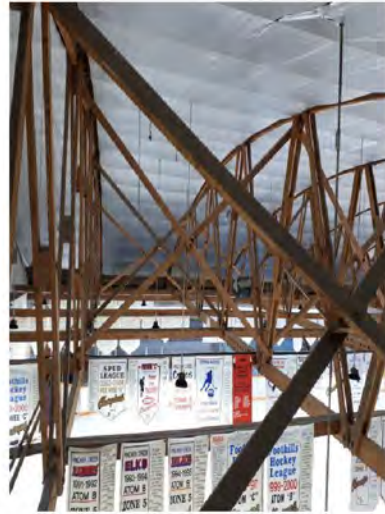
Photo #S4: Cross bracing between trusses over arena.

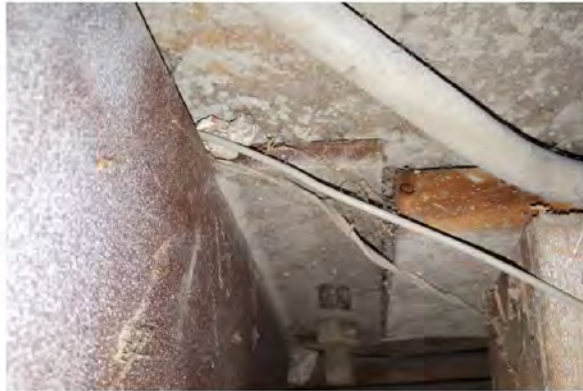
**Photo #S7:** Wood truss-concrete column connection.

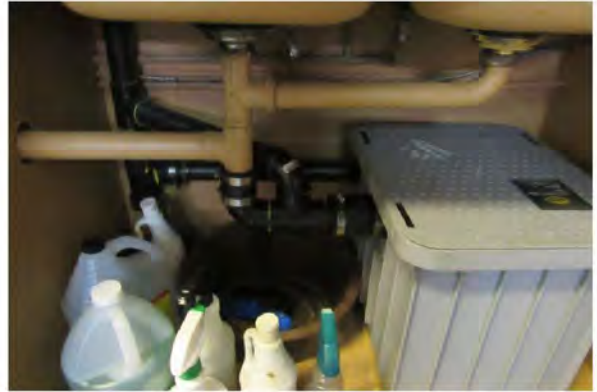
Photo #M2: Grease trap and piping.

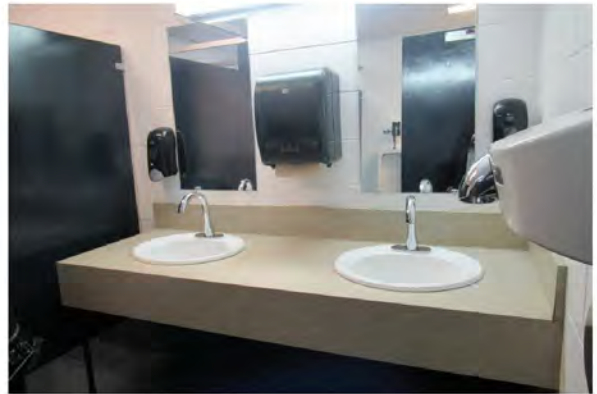
**Photo #M4:** Counter mounted sinks in washroom.

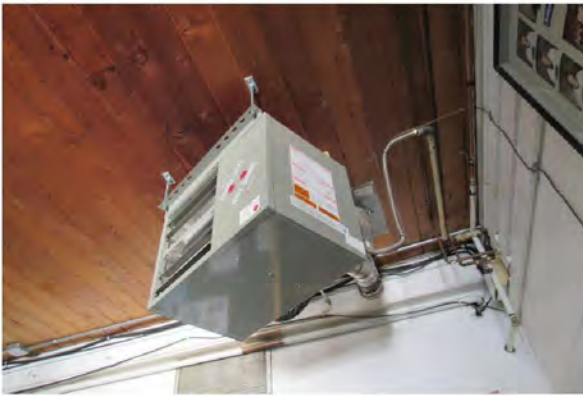
**Photo #M5:** Ceiling mounted radiant heater.

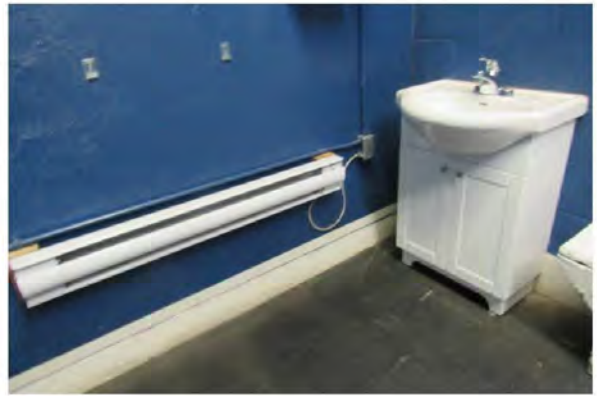
**Photo #M6:** Hydronic baseboard heater.

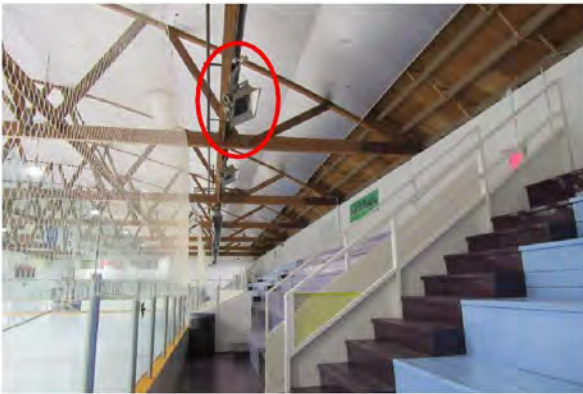
**Photo #M7:** Overhead electric radiant heaters.

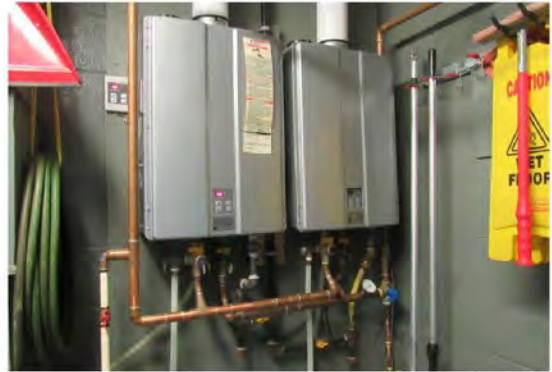
**Photo #M8:** RINNAI instant hot water heaters.

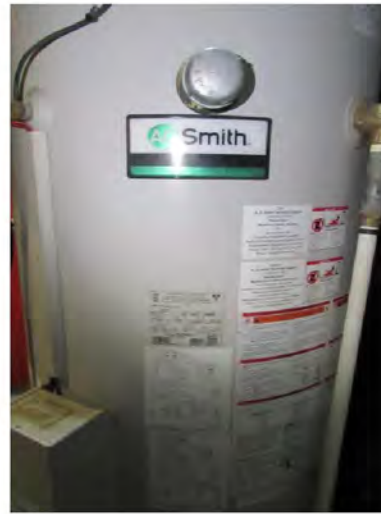
**Photo #M10:** AO Smith water heater.

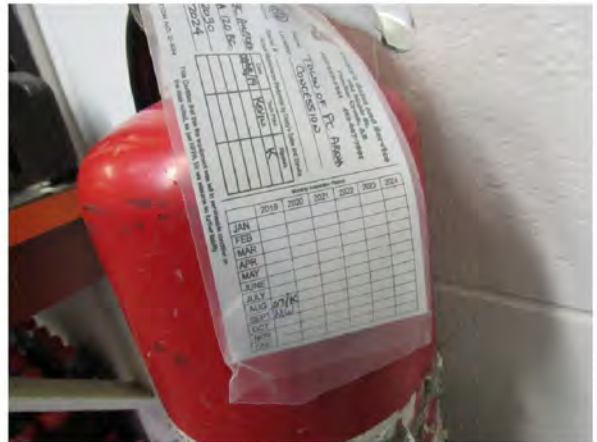
Photo #M12: ABC fire extinguisher.

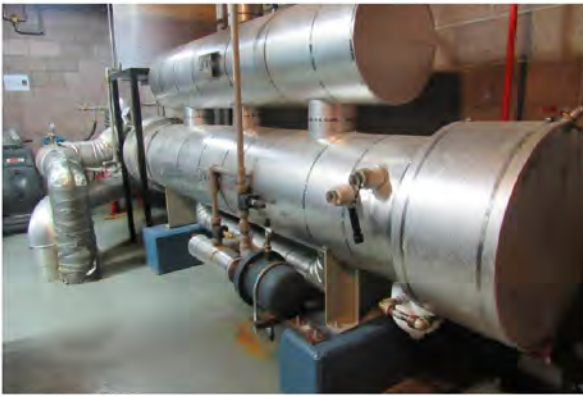
**Photo #M13:** Ice plant chiller/heat exchanger.

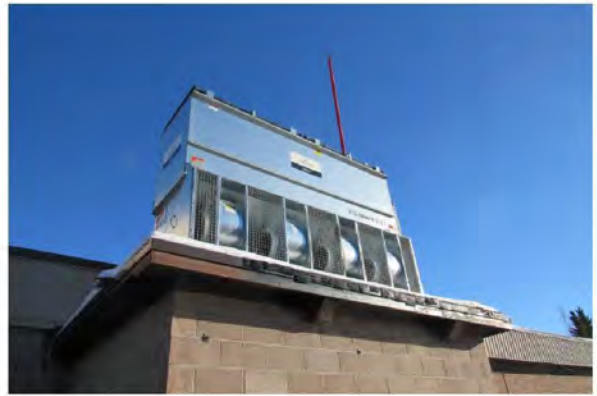
**Photo #M14:** Cooling tower for ice plant.

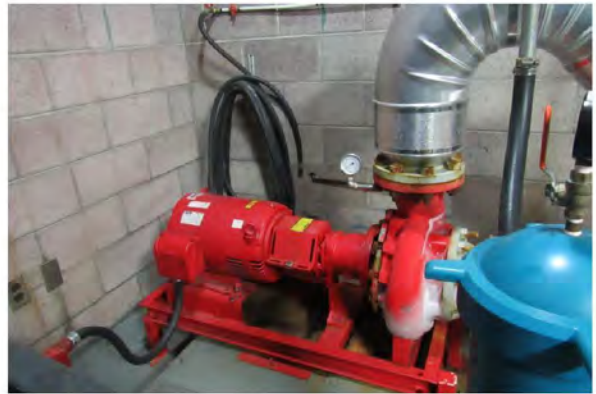
**Photo #M16: Brine Pump.**

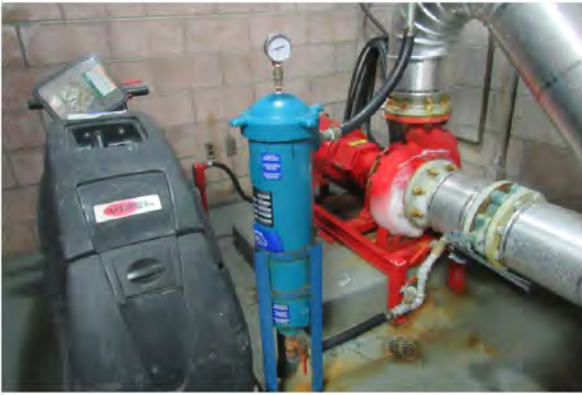
**Photo #M17:** Brine pressure gauge.

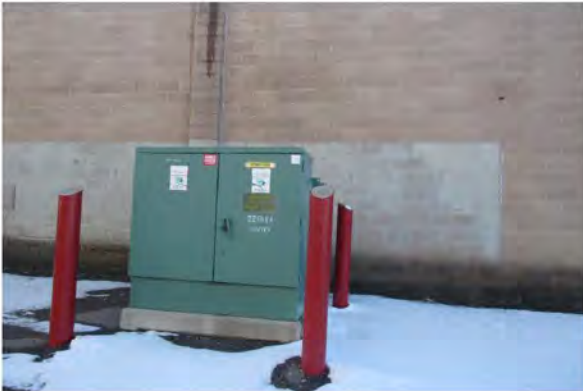
**Photo #E1:** On site electrical transformer.

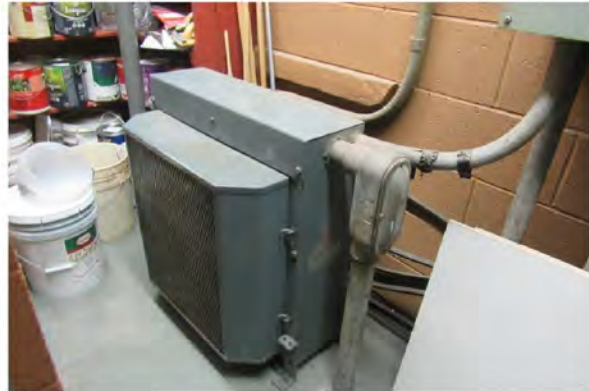
**Photo #E2:** Interior transformer.

E02.2) Replacement of interior transformers.

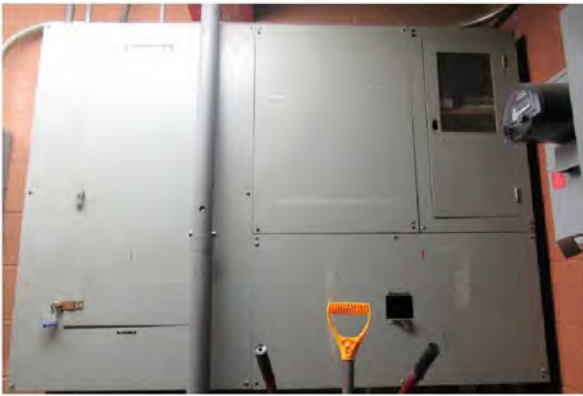
I.D#	SYSTEM/COMPONENT	DESCRIPTION	CR	Cat.	COMMENTS/ASSESSMENT
E02.1	Primary Distribution (Switchgear, CDPs, splitters, disconnects)	~1964: Primary power is supplied through a central distribution panel manufactured by Westinghouse, rated at 400 Amps, 277/480 Volts, 3 phase 4 wire.	3	C	Primary distribution equipment is outdated and will require replacement in the short-term time frame of this report. A cost for replacement is provided in the capital reserve table.
E02.2	Interior Transformers	~1964: Two interior transformers are present in the electrical service room. Transformers are as follows:  Manufacturer: Polygon Location: Electrical Room Rating: 50 KVA  Manufacturer: General Electric Location: Electrical Room Rating: 45 KVA	3	C	No concerns observed or reported, but transformers are outdated and will require replacement within the time frame of this report. A cost will be provided for replacement in the capital reserve table.

**Photo #E3:** Central distribution panel/switchgear.

E02.1) Replacement of central distribution panel in electrical room.

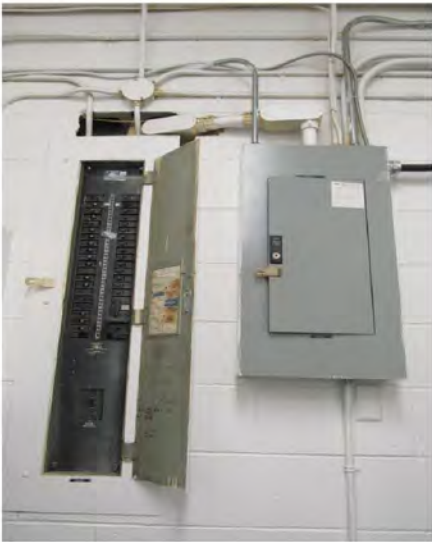
**Photo #E5:** Subpanels located in referee room.

E02.3) Replacement of subpanels throughout the ice rink.

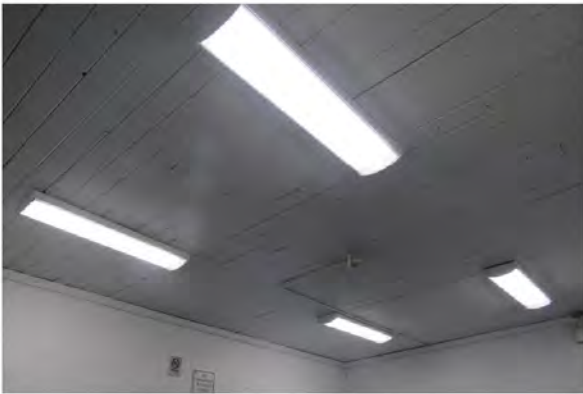
**Photo #E7:** Ceiling mounted fluorescent lights.

E03.1) Replacement of interior fluorescent lighting.

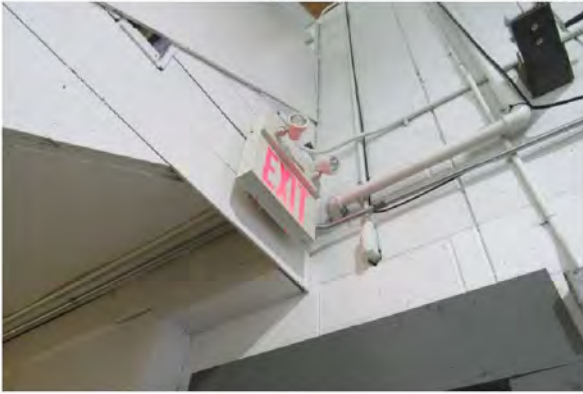
**Photo #E9:** Exit and emergency lighting.

E03.3) Replacement of emergency lighting packs.

E03.4) Replacement of LED exit signs.
