# TOWN OF PINCHER CREEK COUNCIL MEETING AGENDA

<b>SUBJECT:</b> Operations Facility - Condition Assessment & Needs Assessment	
<b>PRESENTED BY:</b> Laurie Wilgosh, Chief Administrative Officer	<b>DATE OF MEETING:</b> 10/24/2022

## Program Plan and Conceptual Design for the Operations Facility 1068 Kettles St, Pincher Creek, AB

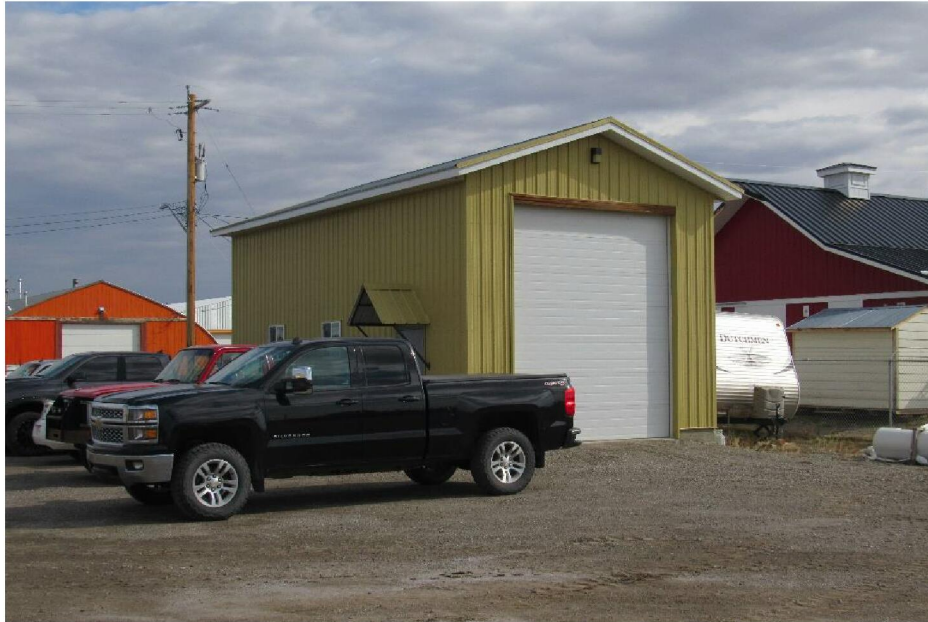
General view of the East Shop.

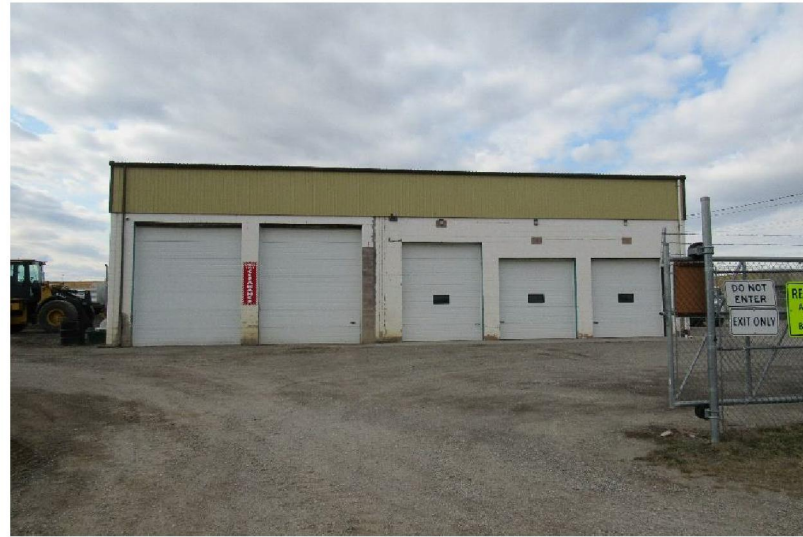
**Photo #A2:** Gravel paved driveway.

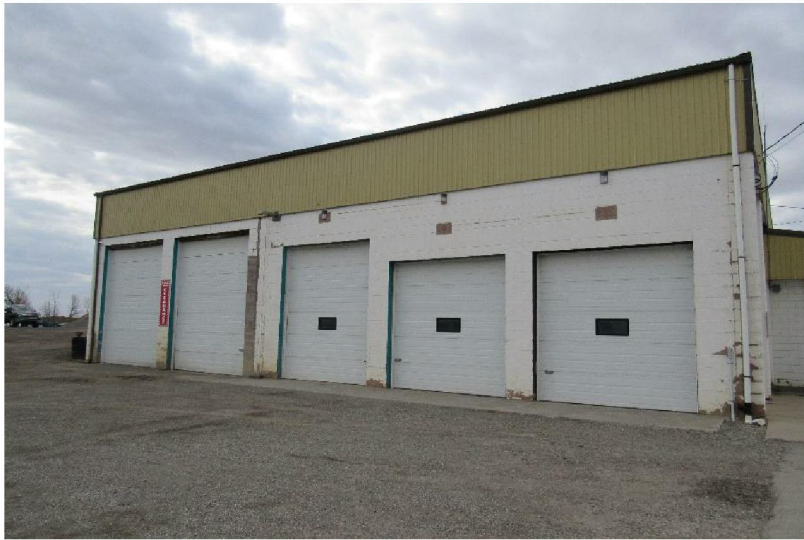
Photo #A3: General view of the Main Shop.

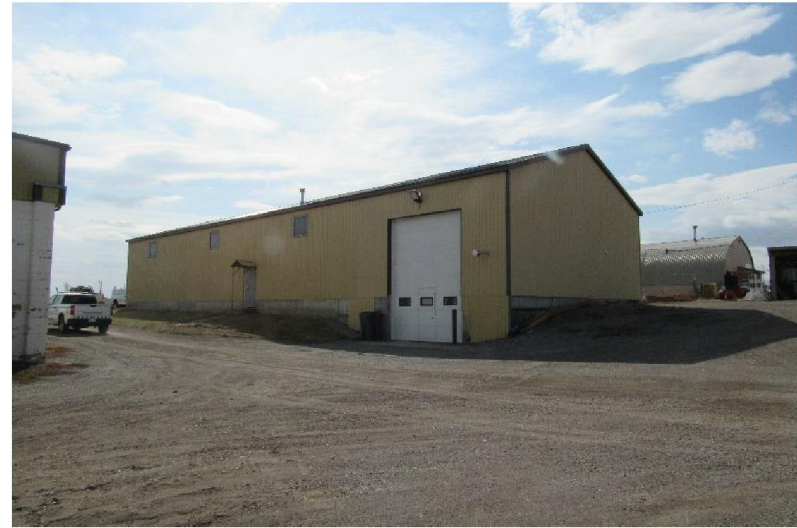
Photo #A4: General view of the South Shop.

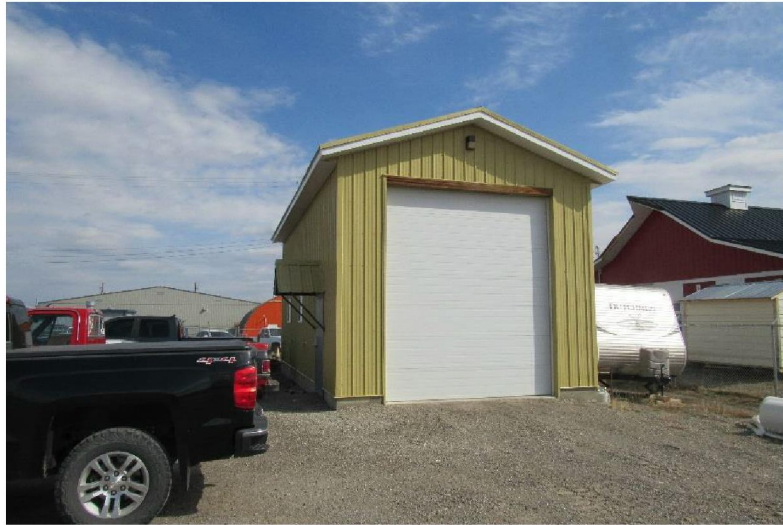
Photo #A5: General view of the East Shop.

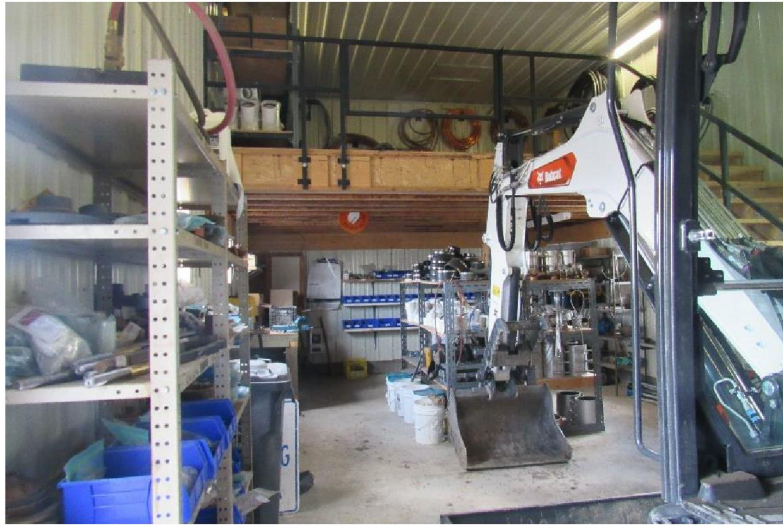
Photo #A13: General interior finishes in the East Shop.

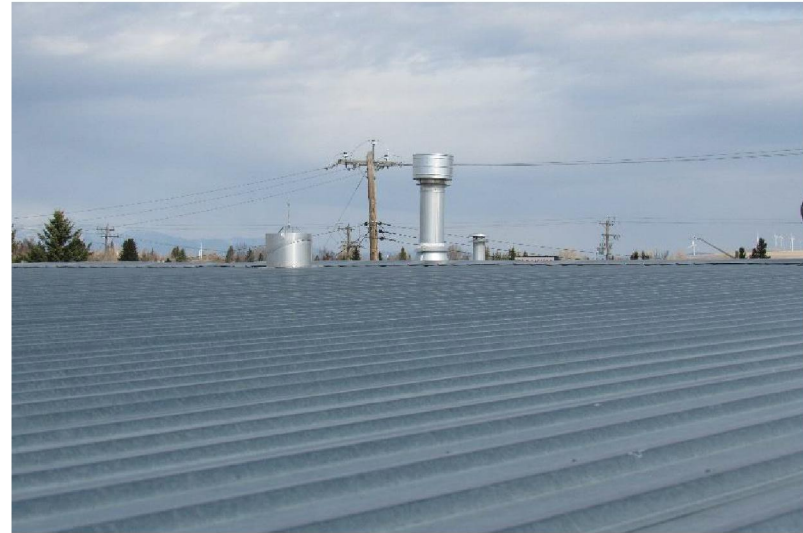
Photo #A14: General view of the Main Shop roof.

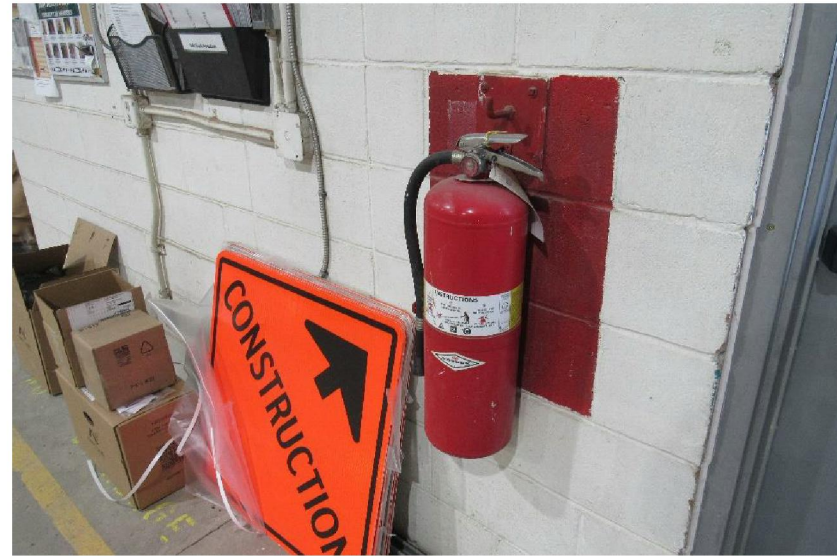
**Photo #M4:** Typical portable dry-type ABC fire extinguishers in the North Building.

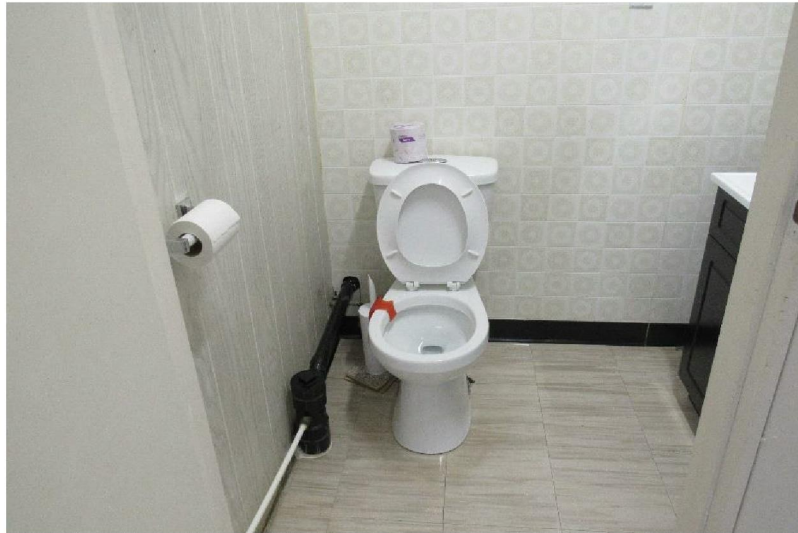
**Photo #M7:** Typical fixture in the Main Shop washrooms.

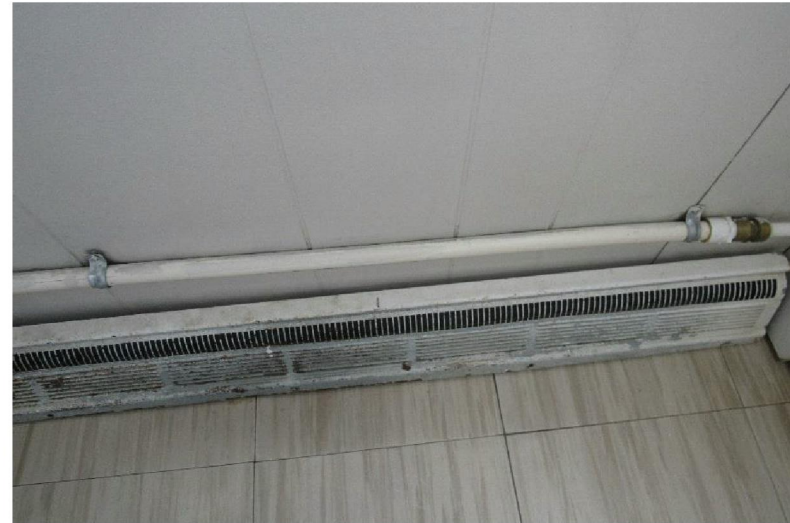
**Photo #M8:** Typical baseboard found in the Main Shop washroom area.

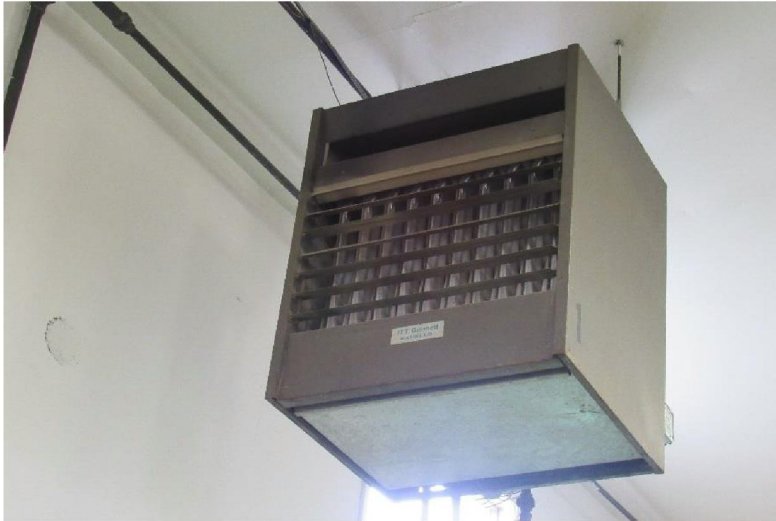
**Photo #M9:** Unit heater in the South Shop facility.

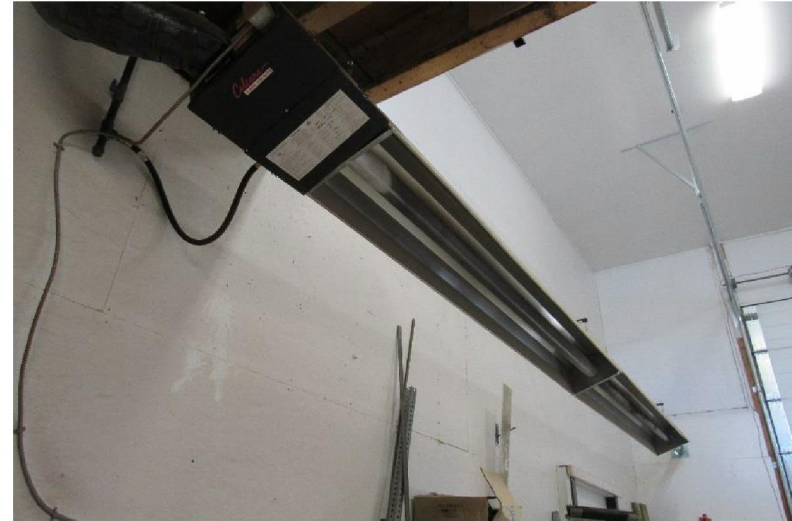
**Photo #M10:** Radiant heater found in the South Shop mini excavator loading bay.

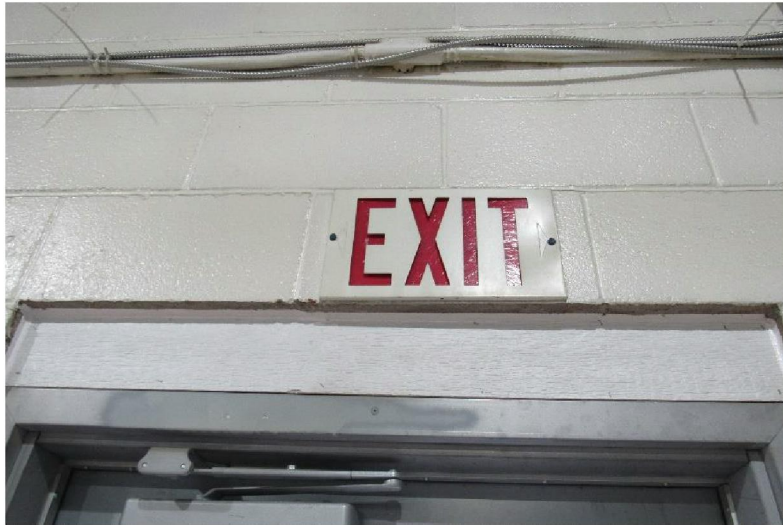
**Photo #E3:** Typical emergency exit lighting in the Main Shop.

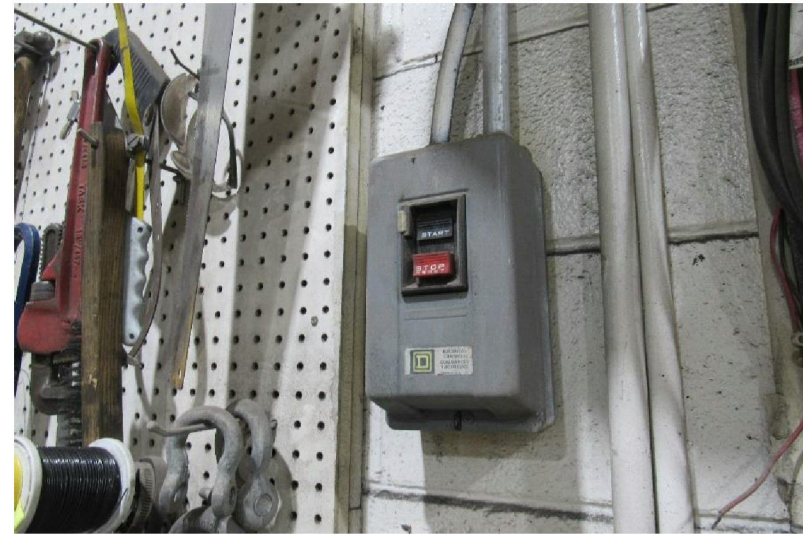
**Photo #E6:** Motor starter in the Main Shop.

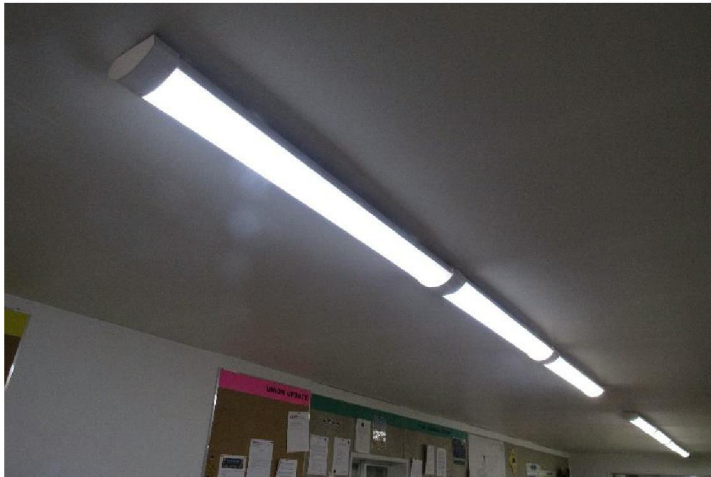
**Photo #E9:** Typical T-8 lighting fixtures, located in the Main Shop lunchroom.

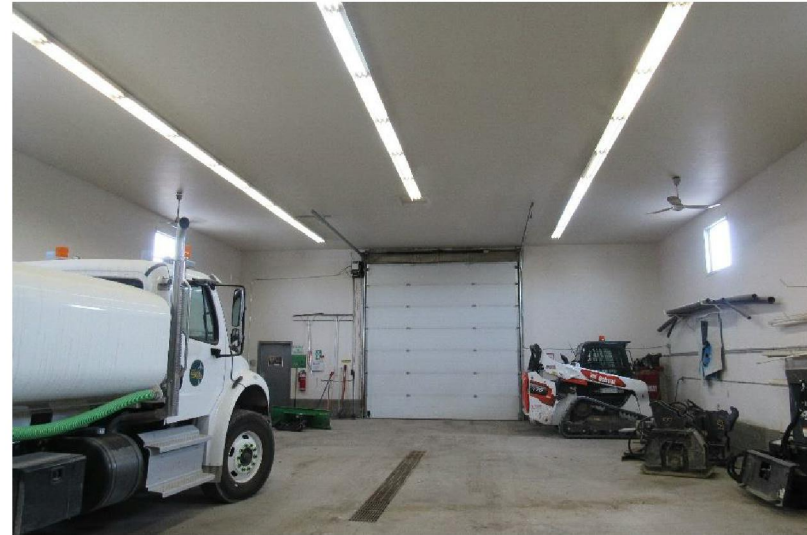
**Photo #E10:** Typical T-8 lighting fixtures of garbage truck loading bay, South Shop.
