# TOWN OF PINCHER CREEK COUNCIL MEETING AGENDA

Monday, May 9, 2022 at 6:00 p.m.

# FINAL REPORT

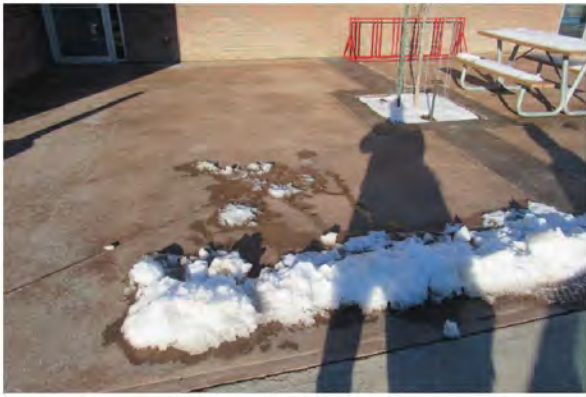
**Photo #A3:** Concrete pad walkway near front entrance.

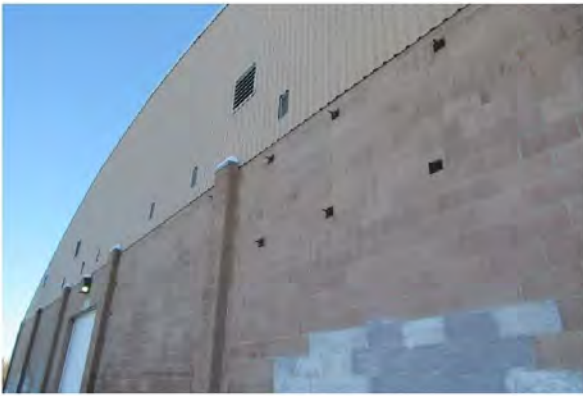
**Photo #A5:** Exterior cladding finishes.

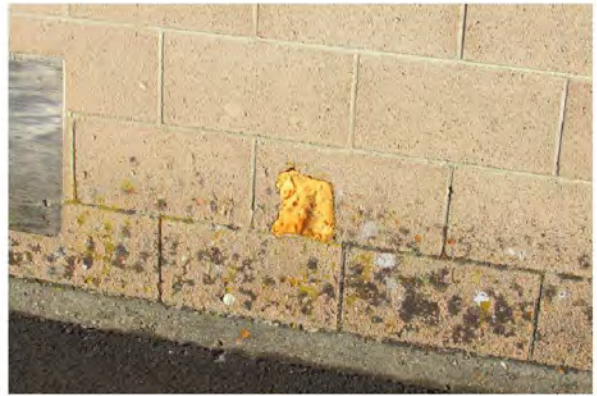
**Photo #A6:** Previous fix in cladding exposed to elements.

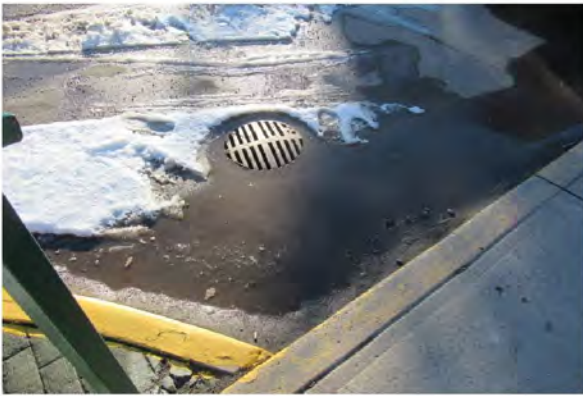
**Photo #A9:** Storm sewer in street near entry drive.

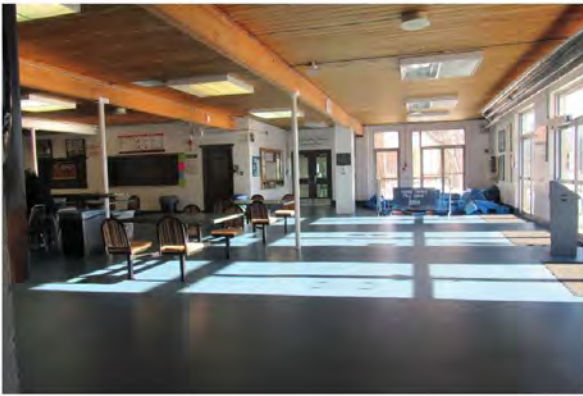
**Photo #A11:** Main lobby interior finishes.

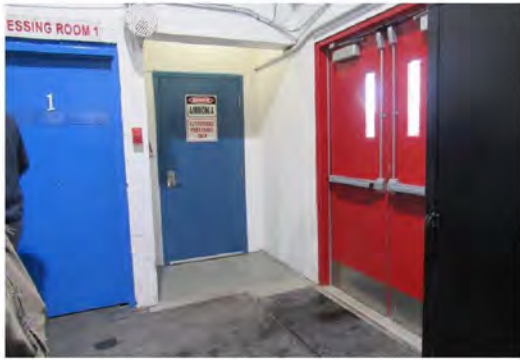
Photo #A15: Ammonia plant entry and utility egress doors.

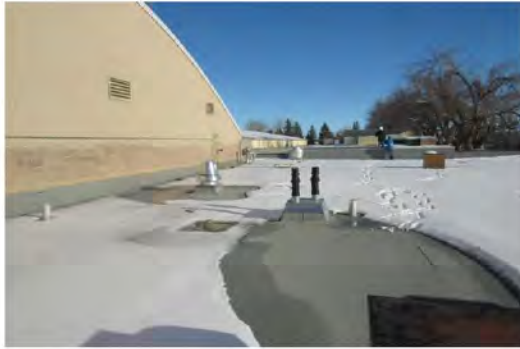
**Photo #A19:** SBS flat roof system.

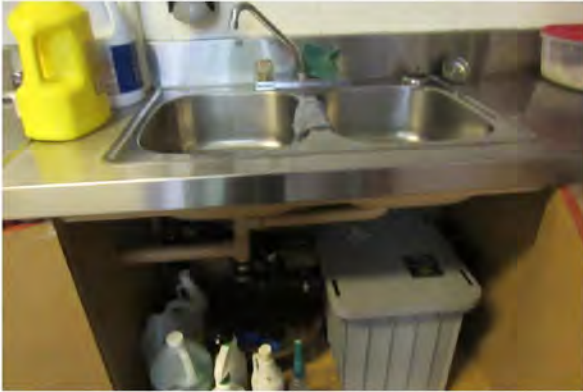
Photo #M1: Stainless steel double basin sinks in canteen.

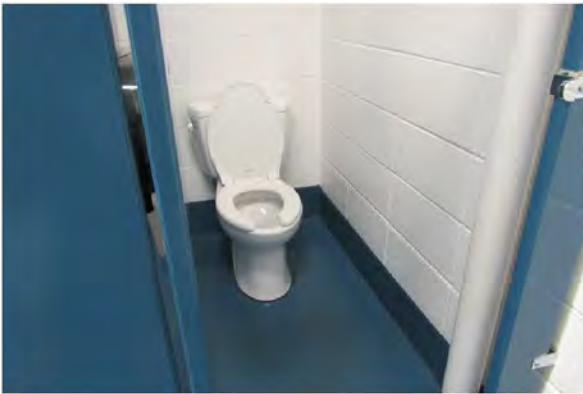
**Photo #M3:** Water closet fixture.

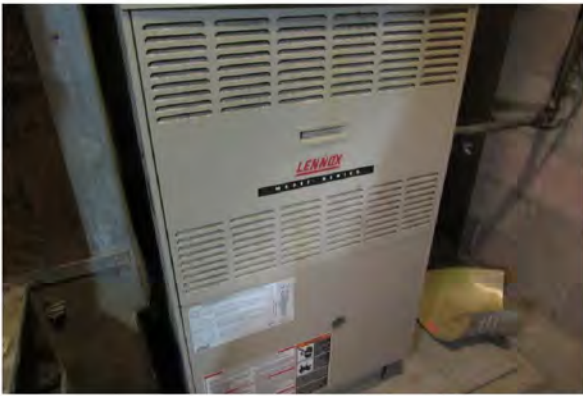
**Photo #M9:** Lennox furnace.

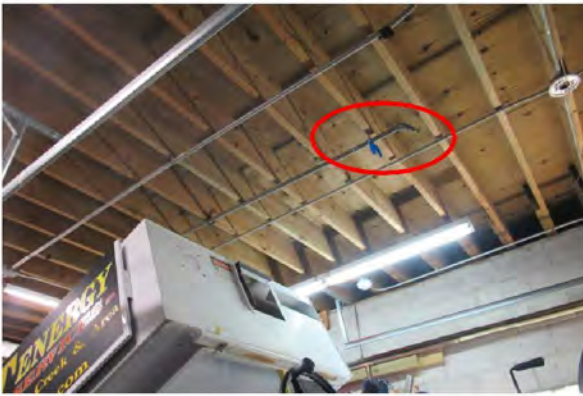
Photo #M11: Wet pipe sprinkler system in Zamboni room.

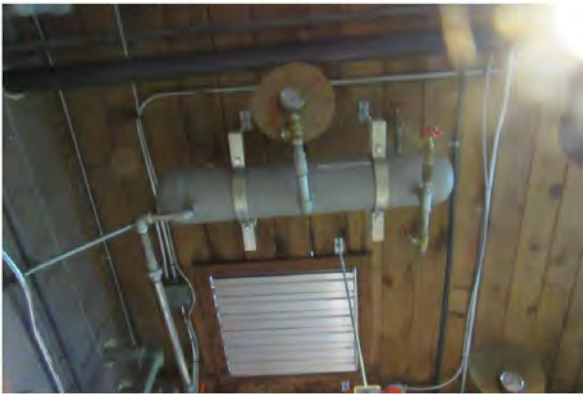
**Photo #M15: Oil interceptor.**

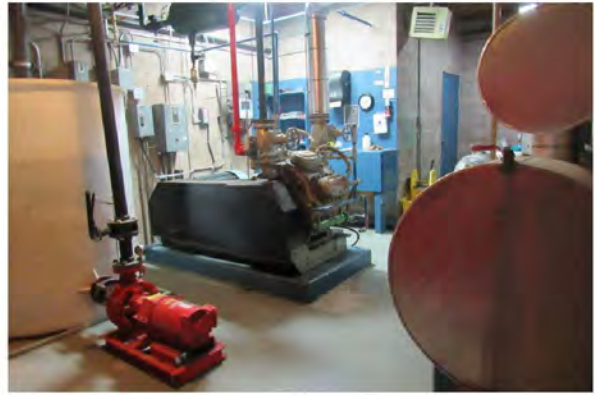
**Photo #M18:** Compressor and circulation pumps in ice plant.

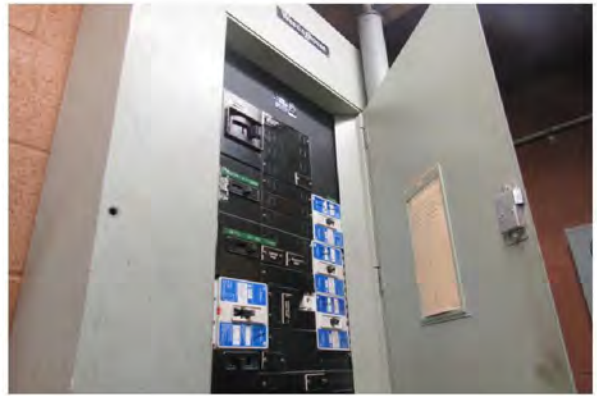
**Photo #E4:** Circuit layout in CDP.

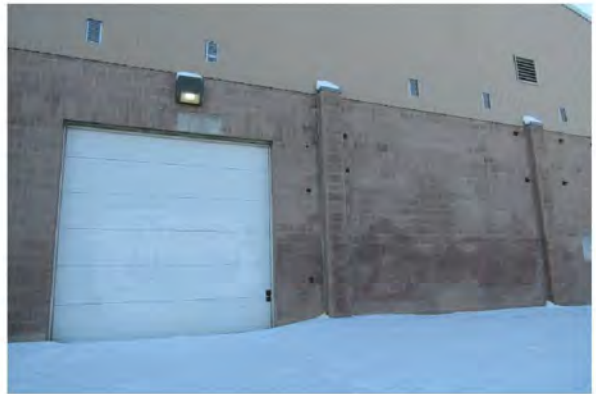
**Photo #E8:** Exterior LED light.

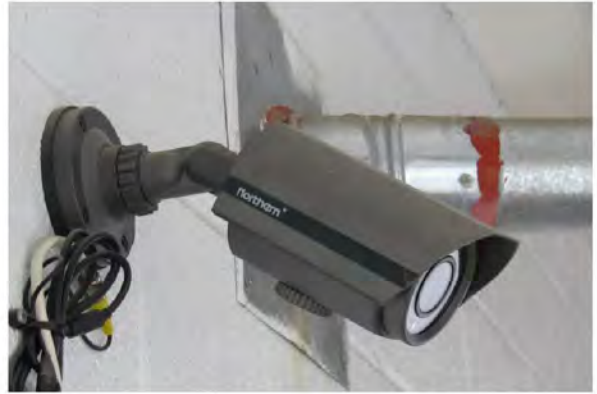
**Photo #E10:** Northern surveillance camera

E06.4) Replacement of surveillance video.
