# TOWN OF PINCHER CREEK COUNCIL MEETING AGENDA

<b>SUBJECT:</b> Operations Facility - Condition Assessment & Needs Assessment	
<b>PRESENTED BY:</b> Laurie Wilgosh, Chief Administrative Officer	<b>DATE OF MEETING:</b> 10/24/2022

## Program Plan and Conceptual Design for the Operations Facility 1068 Kettles St, Pincher Creek, AB

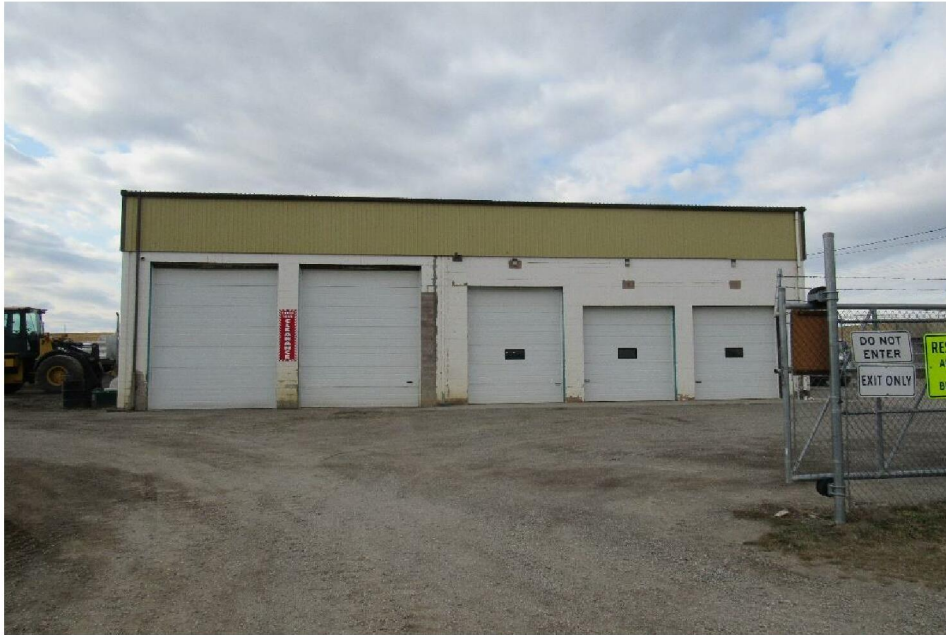
General view of the Main Shop.

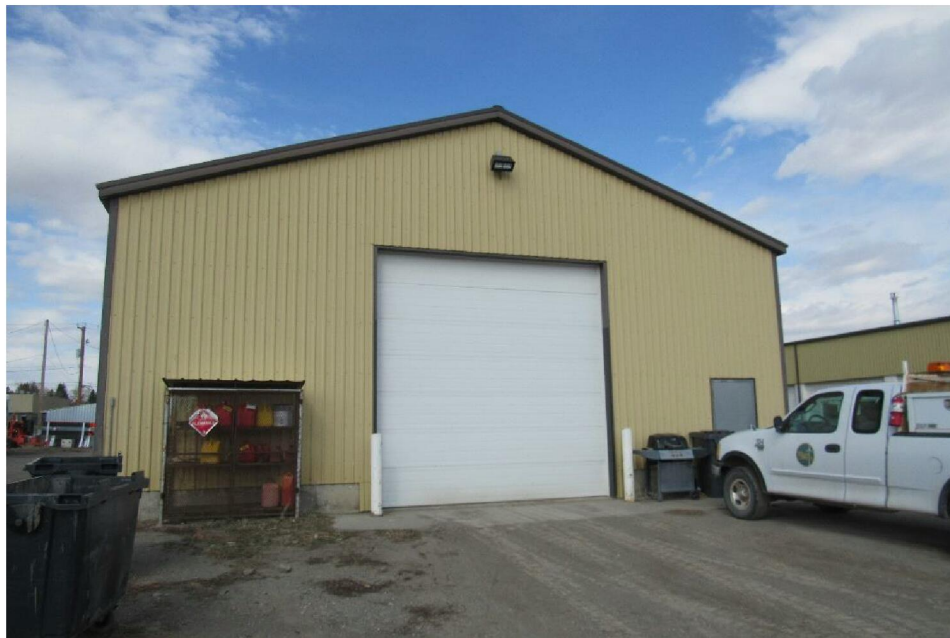
General view of the South shop.

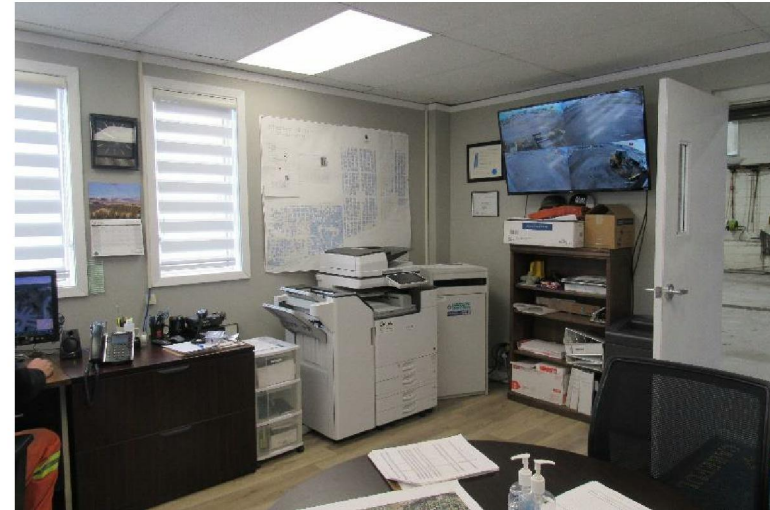
Photo #A6: General overview of the Main Shop office area.

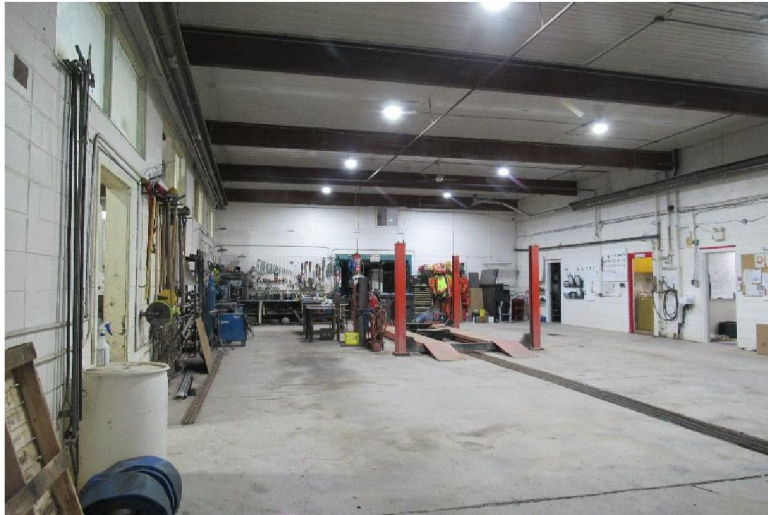
Photo #A7: General view of the bay #1, 2, and 3 in the Main Shop.

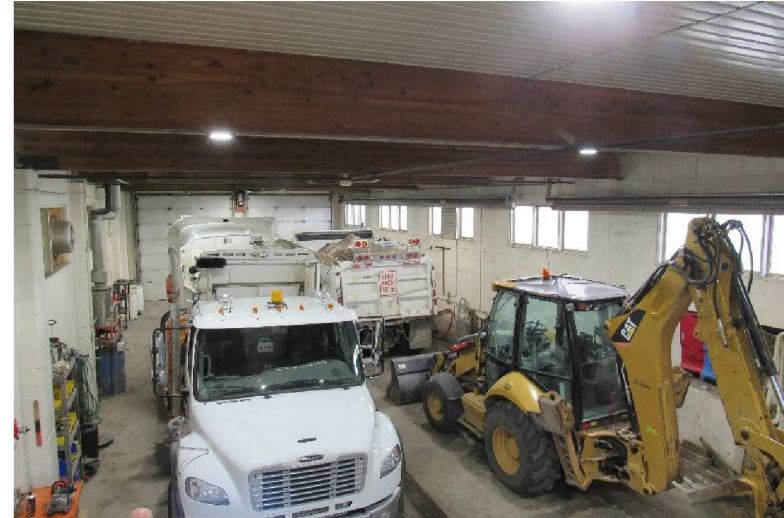
Photo #A8: General view of the bay #4 and 5 in the Main Shop.

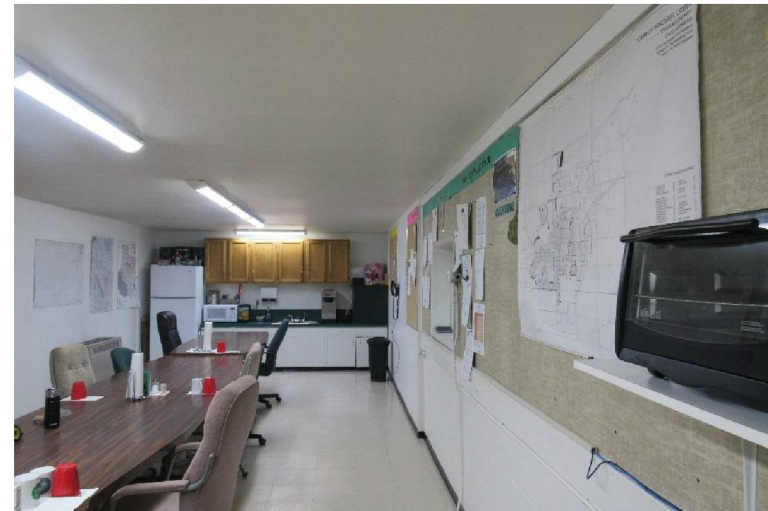
Photo #A10: General view of lunchroom on the Main Shop mezzanine.

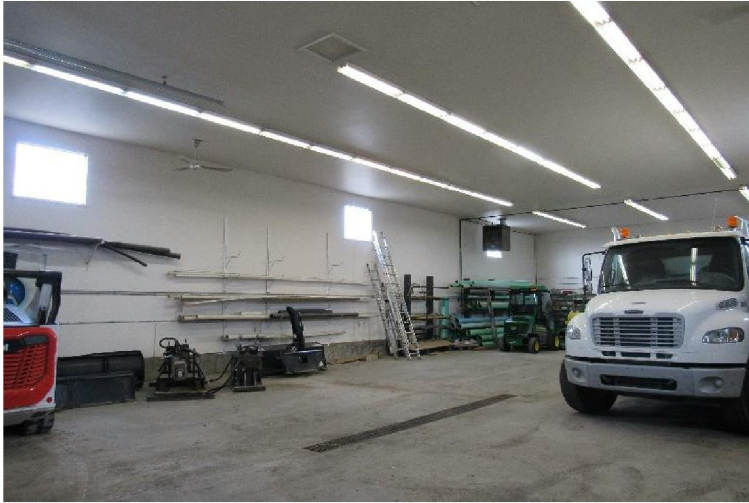
Photo #A11: General view of the South Shop Bay.

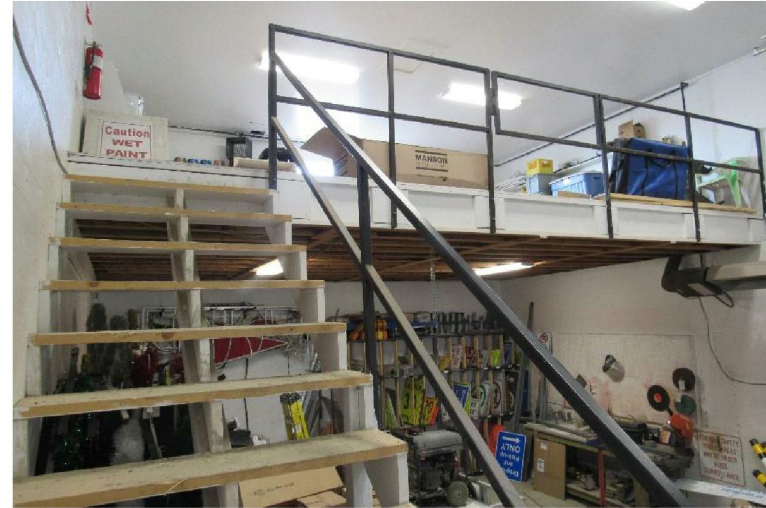
Photo #A12: General view of the South Shop mezzanine floor.

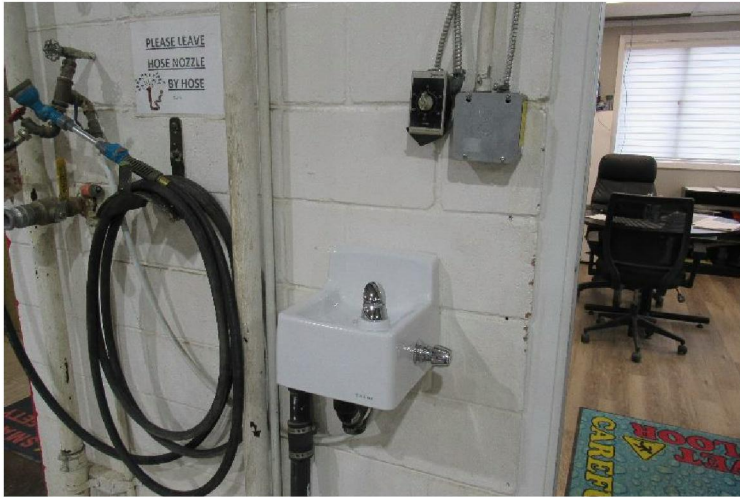
**Photo #M1:** Water fountain located in front of the Main Shop Office area.

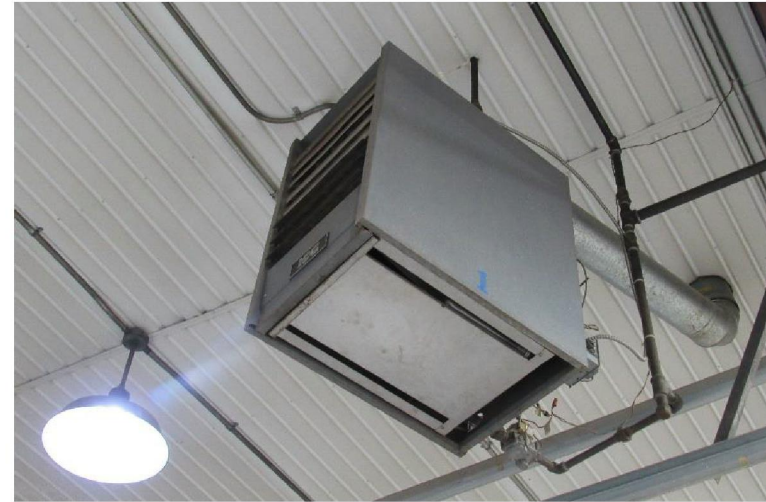
**Photo #M2:** Overhead heater in the Main Shop loading bay.

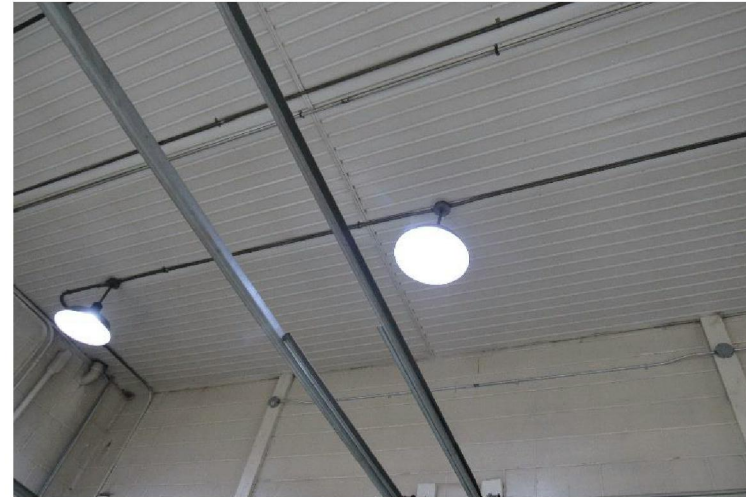
**Photo #E2:** Typical LED light fixture in Main Shop bays.

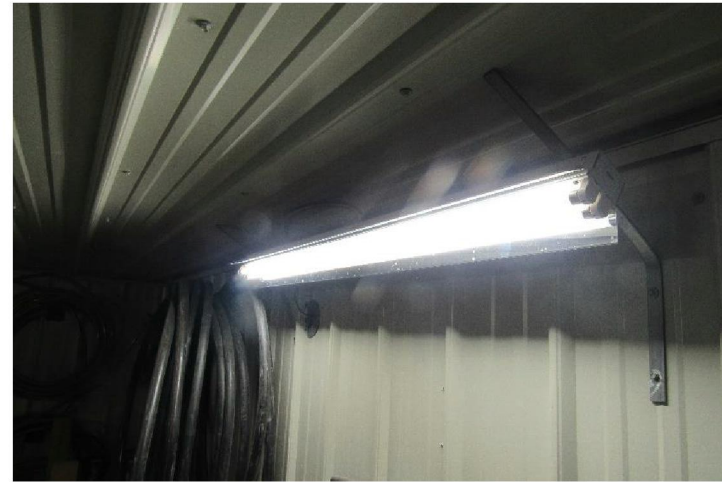
**Photo #E12: Typical T-8 lighting fixture in East Shop.**
